## Maintenance Rating Program

Triangle Expressway

### 2019 Third Quarter Report

### NCTA Triangle Expressway Roadway Maintenance Performance Rating Program; Q3, FY 2019 Rating

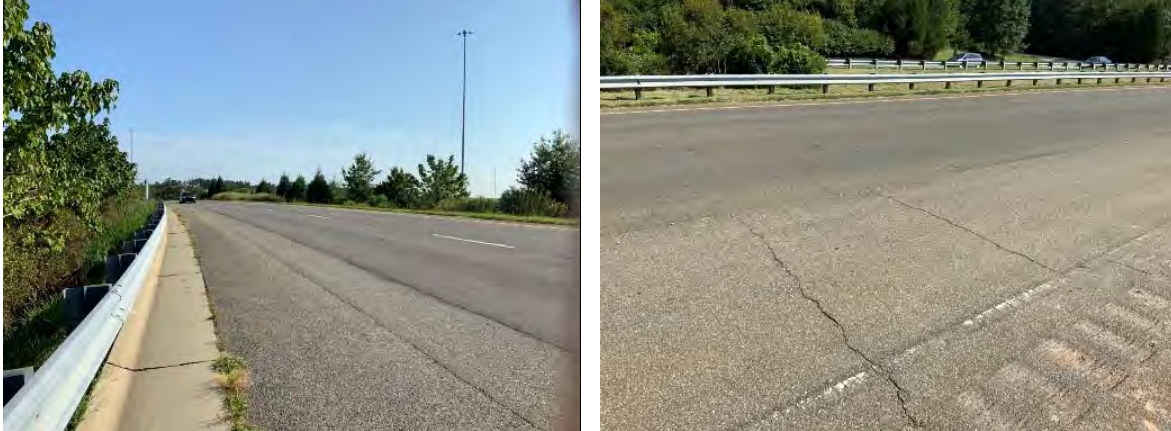
**Figure 3: Pavement Striping Inspection Results Sample**

Pavement Striping (78 rating – 24 of the 33 assets passed): There were 9 pavement striping/markings segments that did not pass inspection, these segments were identified as missing sections or not meeting the required line width, and not reflecting during the nighttime inspection. Two of the pavement striping and marking segments that did not pass inspection are presented in **Figure 3**.

To maintain a well-defined lane delineation throughout the Triangle Expressway, it is recommended that the maintenance provider consider scheduling pavement striping/markings replacement cycles in accordance with the *NCTA Roadway and Facility Maintenance Standards V6*, referenced below.

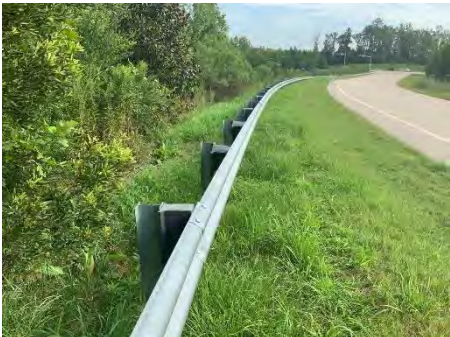
#	Material Type	Object ID	Failure Type	Photo	GIS Reference Page
1	Guardrail	BR_644	Twisted Blocks

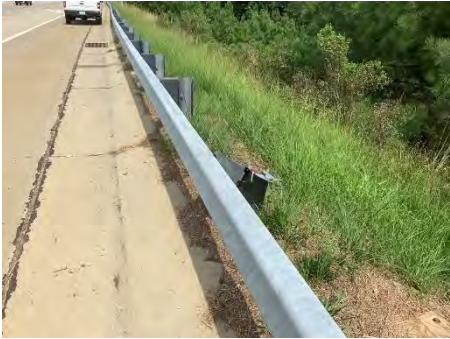
A7
2	Guardrail	BR_657	Functional Damage

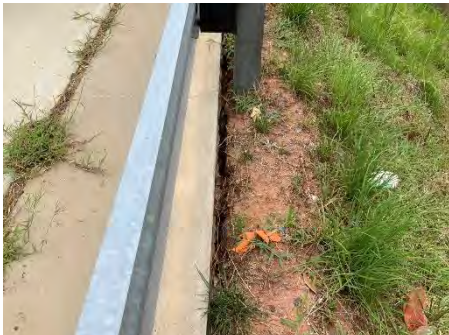
#	Material Type	Object ID	Failure Type	Photo	GIS Reference Page
1	Shoulder Berm Gutter	CG_4	Settlement

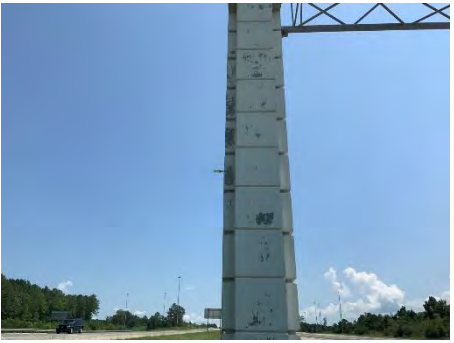
#	Material Type	Object ID	Failure Type	Photo	GIS Reference Page
1	Overhead Sign Support	DS_11	Scaling

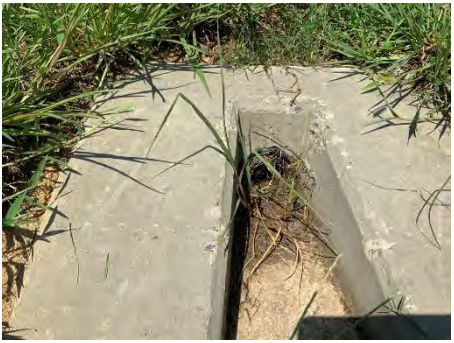
#	Material Type	Object ID	Failure Type	Photo	GIS Reference Page
1	Shoulder Drain	MDP_80	Missing Rodent Screen

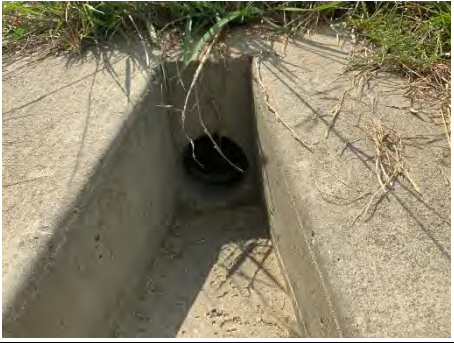
A11
2	Shoulder Drain	MDP_89	Missing Rodent Screen

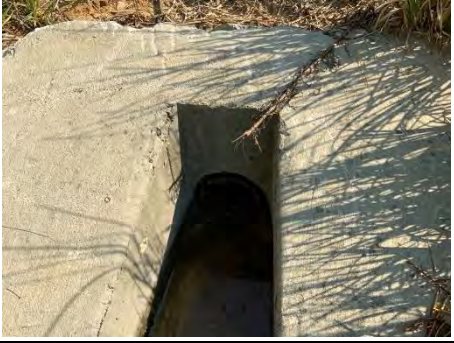
A18
3	Shoulder Drain	MDP_92	Missing Rodent Screen

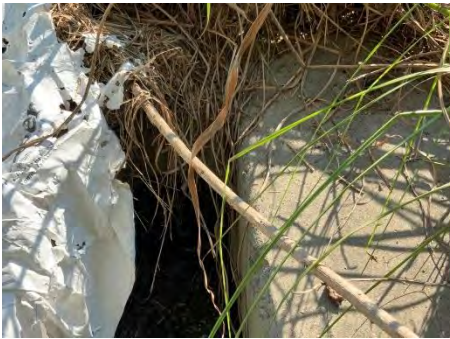
#	Material Type	Object ID	Failure Type	Photo	GIS Reference Page
5	Shoulder Drain	MDP_124	Missing Rodent Screen

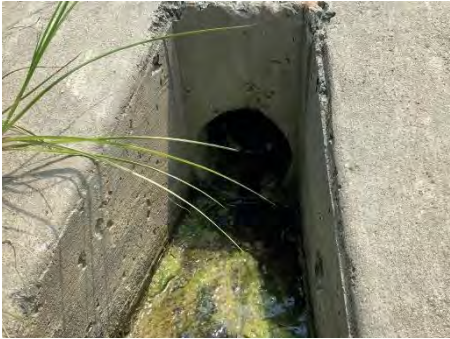
A23
6	Shoulder Drain	MDP_149	Missing Rodent Screen

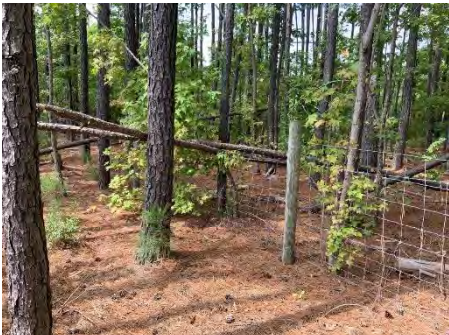
#	Material Type	Object ID	Failure Type	Photo	GIS Reference Page
1	Woven	FN_504	Fence Height

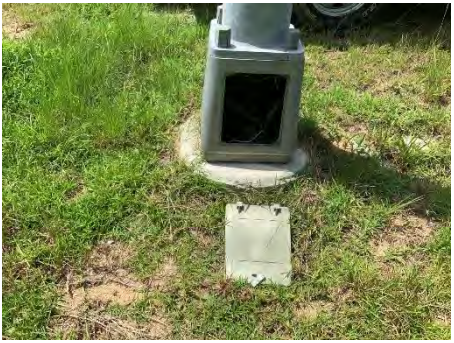
#	Material Type	Object ID	Failure Type	Photo	GIS Reference Page
1	Single Roadway	HL_62	Part Damage

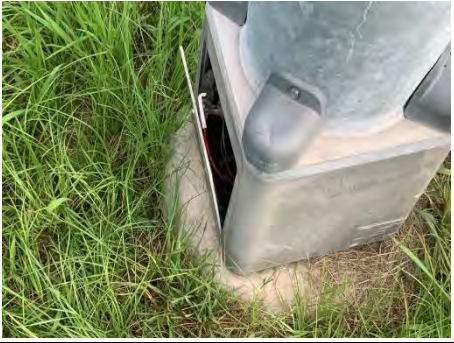
A12
2	Double Roadway	HL_139	Part Damage

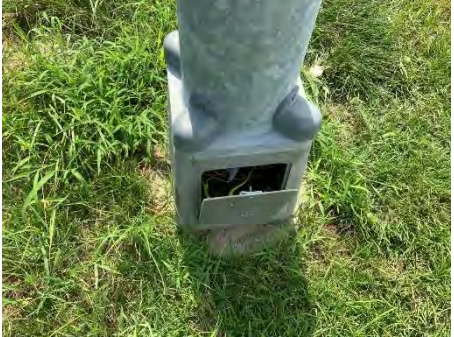
A4
3	Double Roadway	HL_165	Part Damage

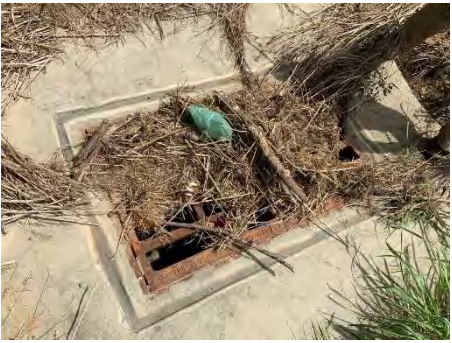
#	Material Type	Object ID	Failure Type	Photo	GIS Reference Page
1	Drop Inlet	IN_90	Obstruction

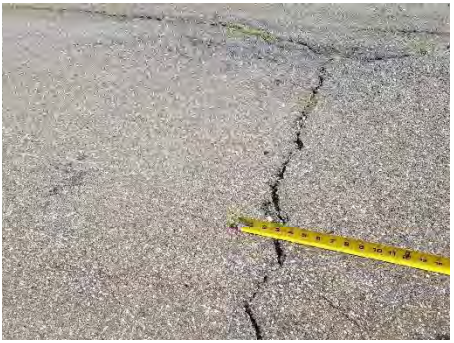
#	Material Type	Object ID	Failure Type	Photo	GIS Reference Page
1	Asphalt	LS_267	Unsealed Cracks

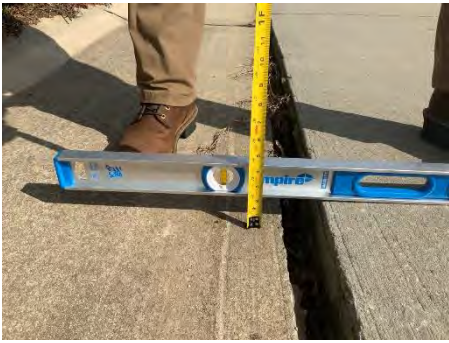
#	Material Type	Object ID	Failure Type	Photo	GIS Reference Page
1	Concrete	LS_149	Pavement Edge Drop-Off

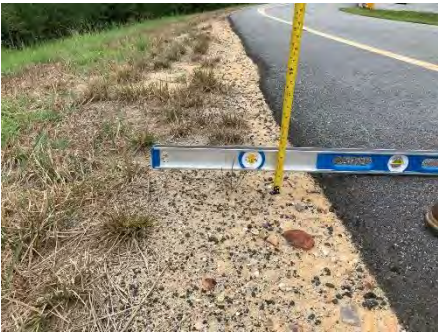
#	Material Type	Object ID	Failure Type	Photo	GIS Reference Page
1	Asphalt	LS_8	Shoulder Drop-Off

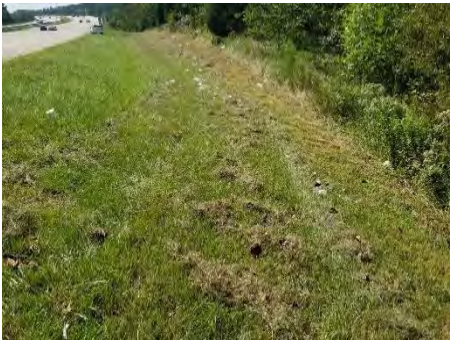
#	Material Type	Object ID	Failure Type	Photo	GIS Reference Page
1	Concrete	LS_343	Litter

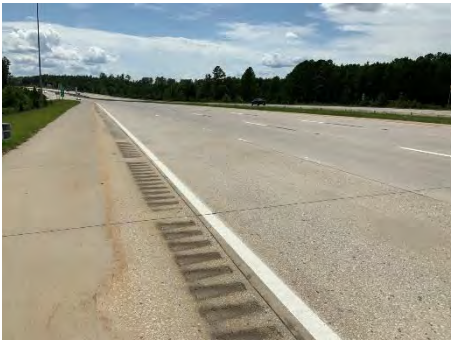
#	Material Type	Object ID	Failure Type	Photo	GIS Reference Page
1	Concrete	LS_59	Line Missing

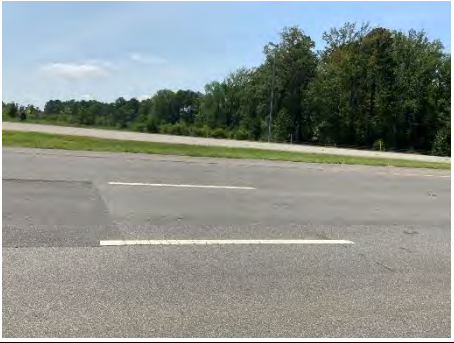
A7
2	Asphalt	LS_229	Line Missing

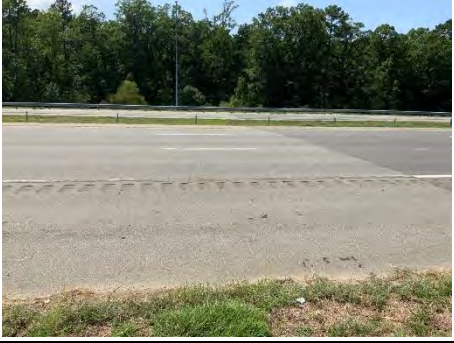
A37
3	Asphalt	LS_231	Line Missing

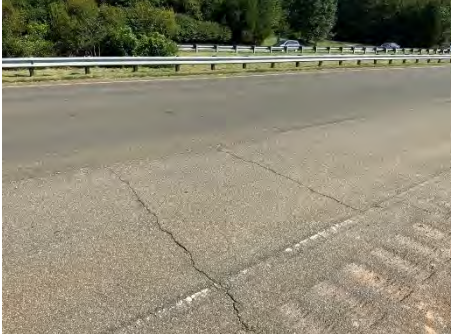
A37
4	Asphalt	LS_267	Line Missing

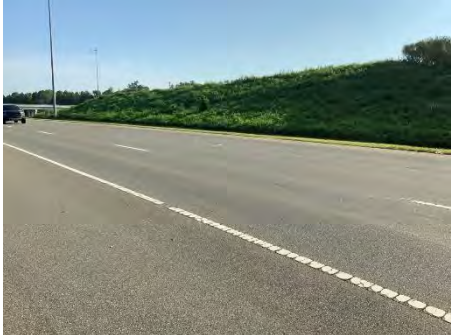
5	Asphalt	LS_301	Line Missing

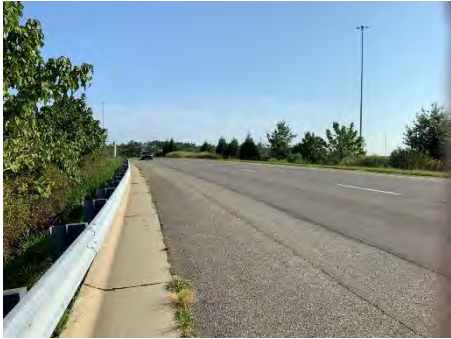
A photograph showing a close-up view of an asphalt road surface. A white dashed line is visible on the right side of the road, but it appears to be missing or faded in the distance. The road is bordered by a grassy embankment on the right.	A3, A4
6	Asphalt & Concrete	LS_303	Line Missing

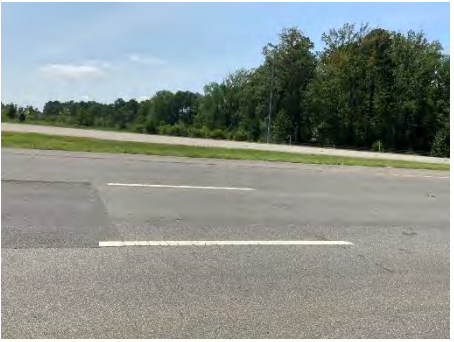
#	Material Type	Object ID	Failure Type	Photo	GIS Reference Page
1	Asphalt	LS_229	Reflective Marker Missing & Nighttime Reflectivity

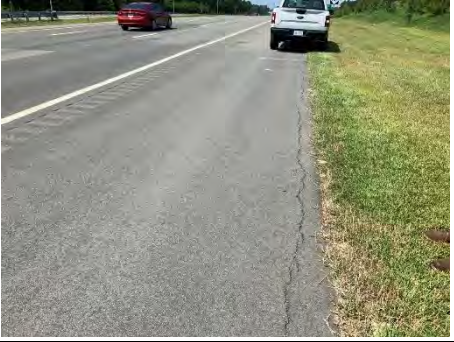
A37
2	Asphalt	LS_231	Reflective Marker Missing & Nighttime Reflectivity

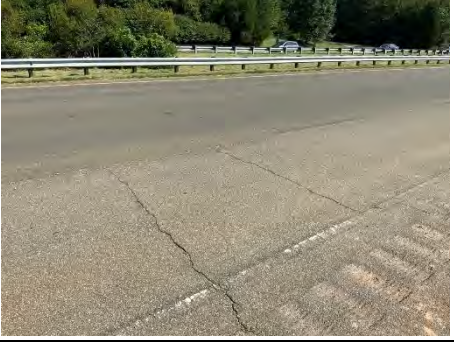
A37
3	Asphalt	LS_267	Reflective Marker Missing & Nighttime Reflectivity

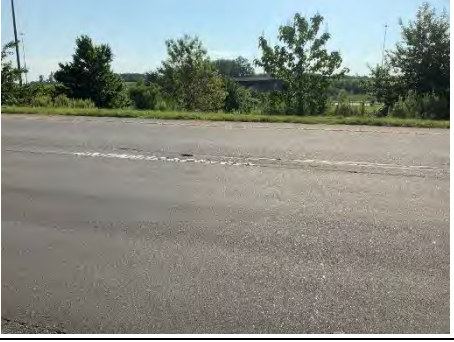
A32
4	Asphalt & Concrete	LS_303	Reflective Marker Missing & Nighttime Reflectivity

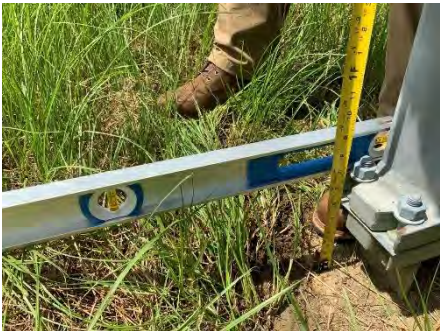
#	Sign Type	Object ID	Failure Type	Photo	GIS Reference Page
1	Toll Payments	SN_167	Slip Base

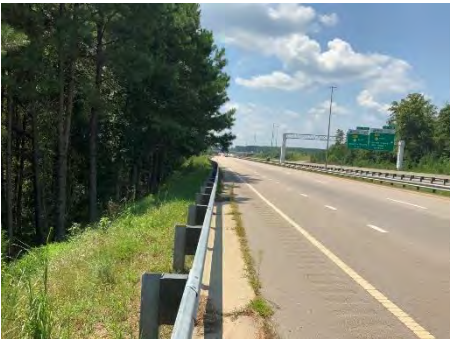
#	Material Type	Object ID	Failure Type	Photo	GIS Reference Page
1	Tree and Brush	TB_149	Vertical Clearance

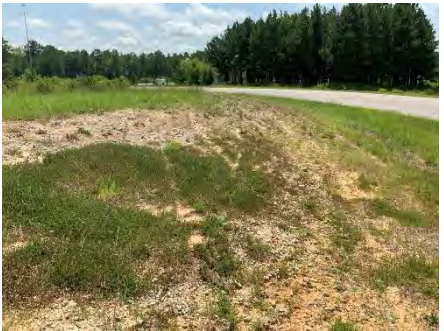
#	Material Type	Object ID	Failure Type	Photo	GIS Reference Page
1	Turf	TF_239	Bare Ground

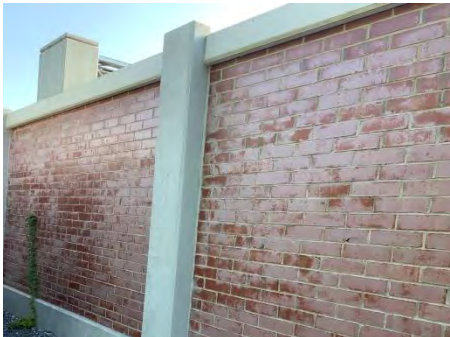
#	Material Type	Object ID	Failure Type	Photo	GIS Reference Page
1	Screen Wall	WL_30	Paint Scale

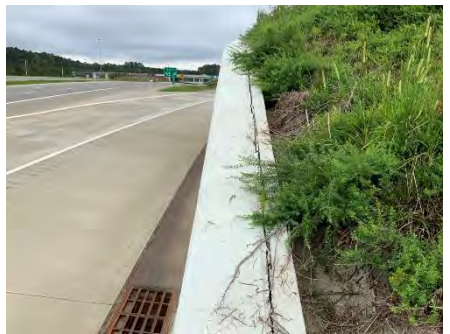
A35
2	Retaining Wall	WL_116	Unsealed Cracks & Vegetation
