NORTH CAROLINA
Turnpike Authority

Maintenance Rating Program

Triangle Expressway

2019 Fourth Quarter and Annual Report

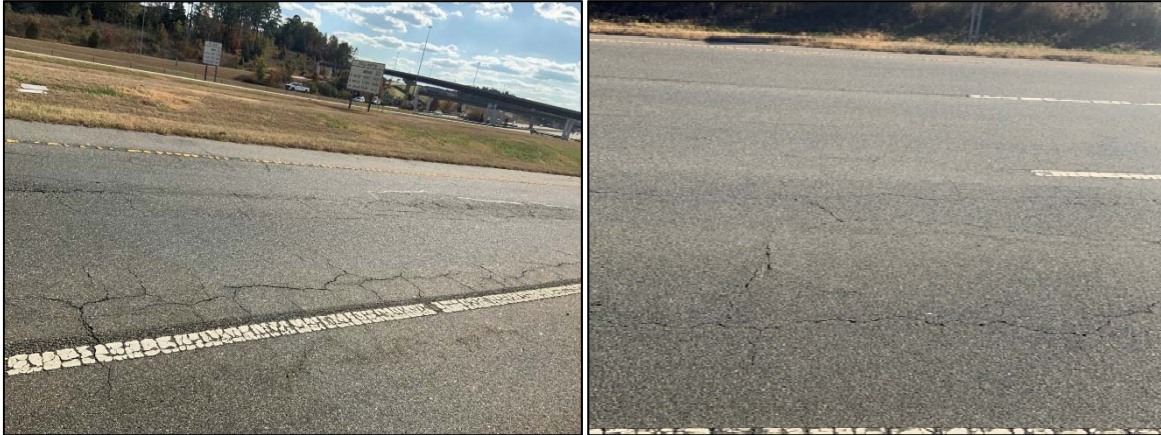
Figure 3: Paved Lanes Asphalt Inspection Results Sample

Paved Lanes Asphalt (75 rating – 3 of the 12 assets did not pass): All three of the asphalt linear segments that did not pass inspection were due to unsealed cracking in the pavement. Two of the segments that did not pass inspection are presented in **Figure 3**.

In accordance with *NCTA Roadway and Facility Maintenance Standards V6*, referenced below, the maintenance provider shall plan regular crack sealing and mill-and-fill repairs in order to maintain safe travel conditions and extend the lifecycle of asphalt pavement throughout the facility. In addition, all unanticipated asphalt pavement deficiencies encountered annually must be repaired.

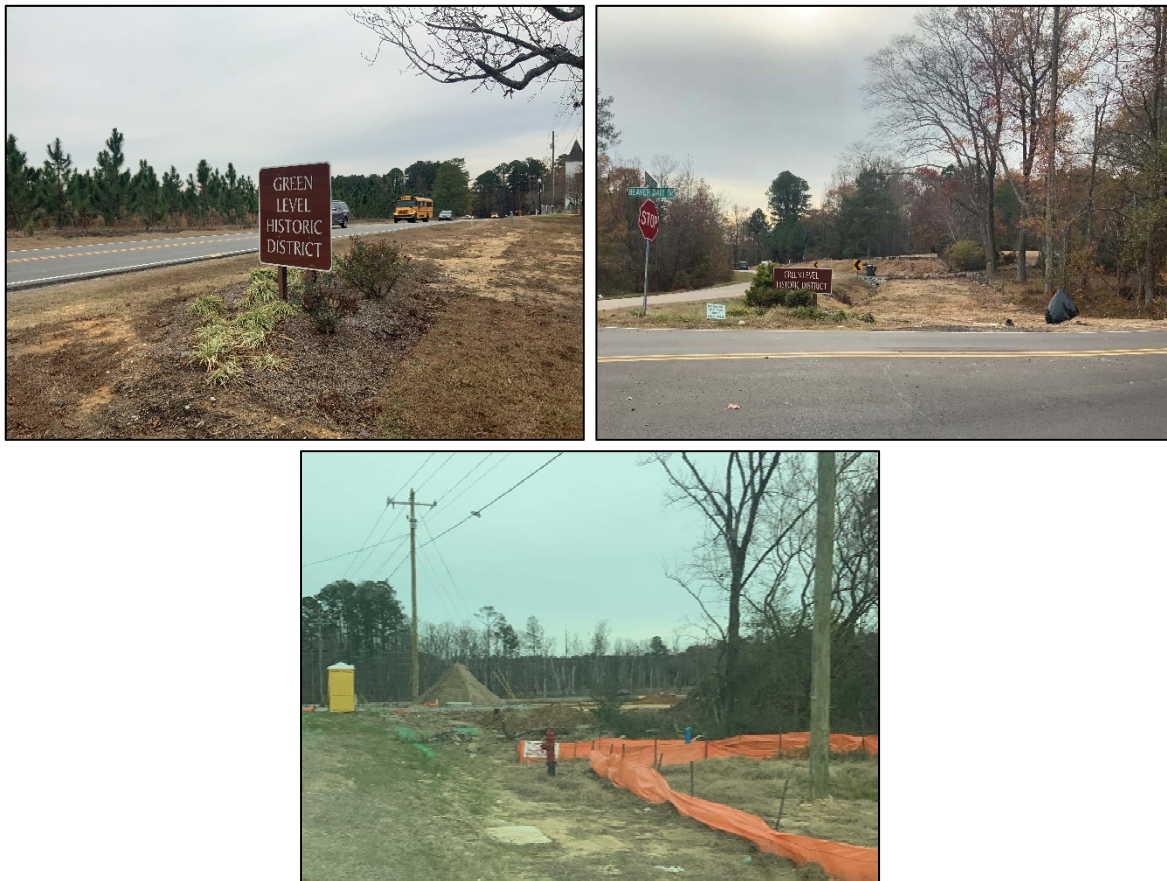
Figure 5: Green Level West Historic District Signs, Landscape Areas

As part of each quarterly inspection, an assessment team visits the three Green Level Historic District signs to conduct a visual inspection of each sign and ensure they are in good standing. Two of the three signs included in the inspection inventory were found to be in good condition, with the landscaped areas being well maintained. The third sign had been temporarily removed due to nearby construction activities. *Figure 5* shows the two signs assessed and the area of the third sign.

This quarter, the two Green Level Historic District signs inspected were found to be in good condition while the third sign was identified to have been removed for a Town of Cary development project near Green Level West Road. Additionally, the landscaped areas surrounding the signs were found to be well maintained.

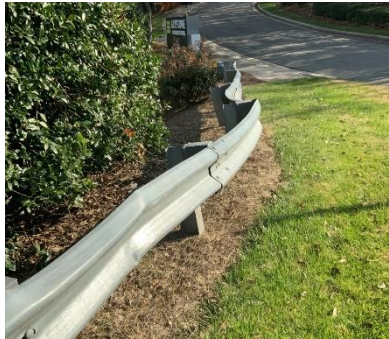
#	Material Type	Object ID	Failure Type	Photo	GIS Reference Page
1	Guardrail	BR_710	Functional Damage

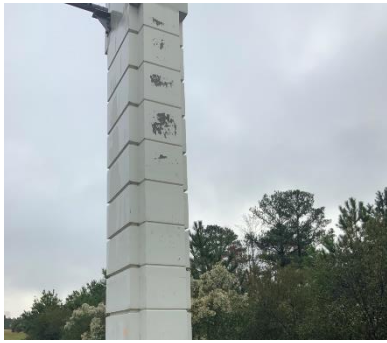
#	Material Type	Object ID	Failure Type	Photo	GIS Reference Page
1	Overhead Sign Support	DS_12	Scaling

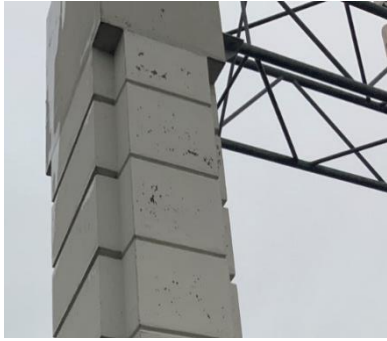
A29
2	Overhead Sign Support	DS_185	Spalling

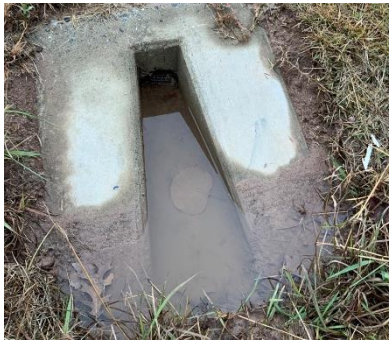
#	Material Type	Object ID	Failure Type	Photo	GIS Reference Page
1	Shoulder Drain	MDP_35	End Damage - Buildup

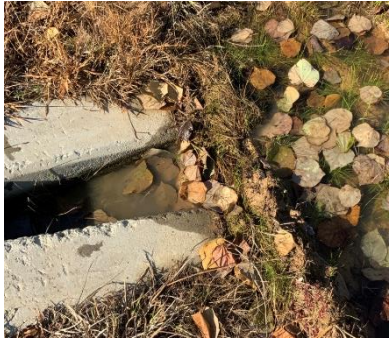
A9
2	Shoulder Drain	MDP_164	End Damage - Buildup

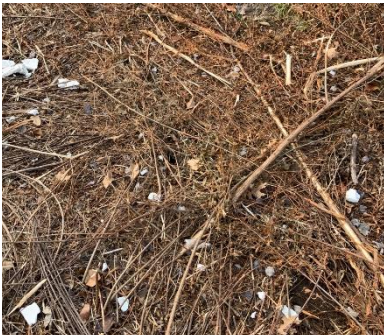
#	Material Type	Object ID	Failure Type	Photo	GIS Reference Page
1	Inlet	IN_593	Obstruction

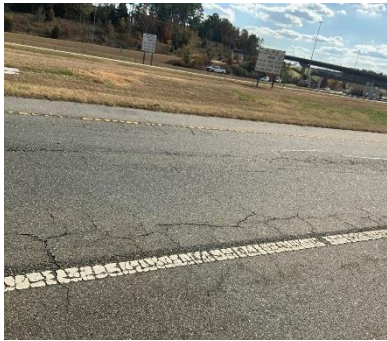
#	Material Type	Object ID	Failure Type	Photo	GIS Reference Page
1	Asphalt	LS_225	Unsealed Cracks

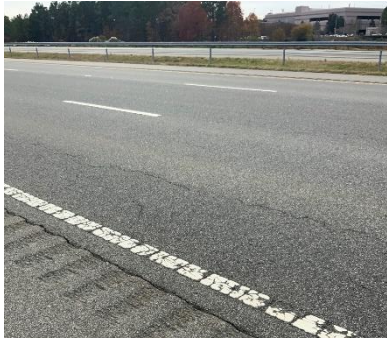
A3
2	Asphalt	LS_244	Unsealed Cracks

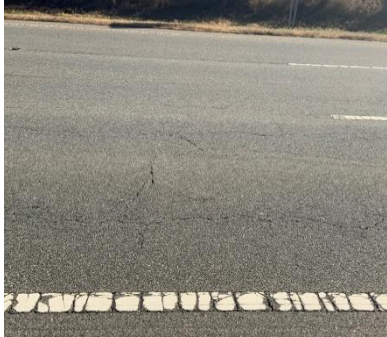
A34
3	Asphalt	LS_302	Unsealed Cracks

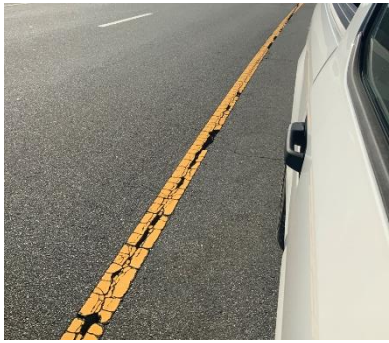
#	Material Type	Object ID	Failure Type	Photo	GIS Reference Page
1	Asphalt	LS_214	Unsealed Cracks

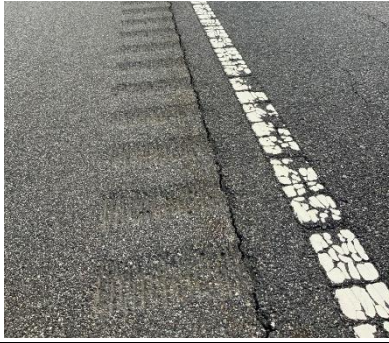
A3
2	Asphalt	LS_244	Unsealed Cracks

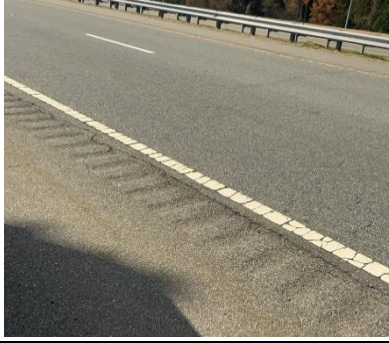
A34
3	Asphalt	LS_264	Unsealed Cracks

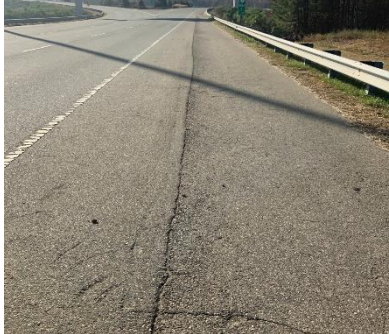
A31
4	Asphalt	LS_302	Unsealed Cracks

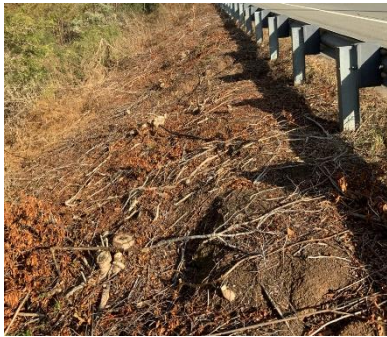
#	Material Type	Object ID	Failure Type	Photo	GIS Reference Page
1	Asphalt	LS_225	Slope - Deviation

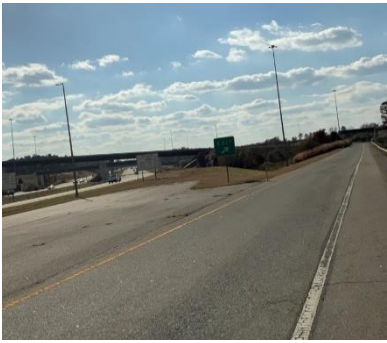
#	Material Type	Object ID	Failure Type	Photo	GIS Reference Page
1	Asphalt	LS_225	Line Missing

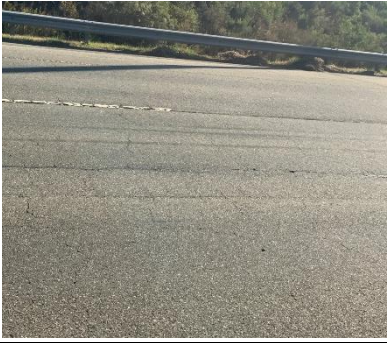
A3
2	Asphalt	LS_302	Line Missing

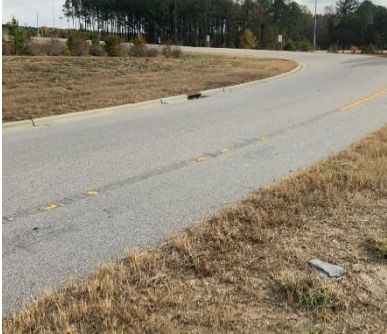
A4
3	Asphalt	LS_556	Line Missing	 	A16
4	Asphalt	LS_650	Line Missing

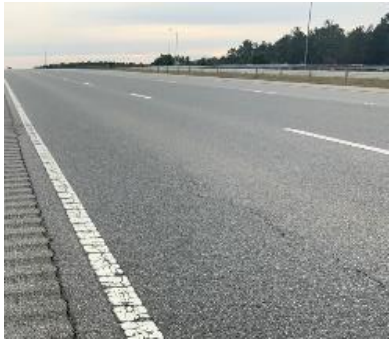
#	Material Type	Object ID	Failure Type	Photo	GIS Reference Page
1	Asphalt	LS_244	Reflective Marker Missing & Nighttime Reflectivity

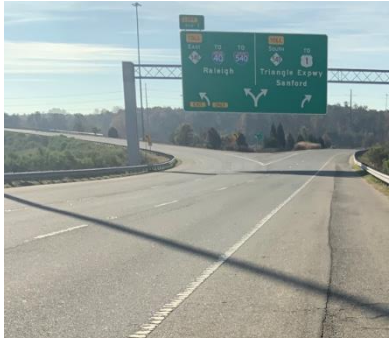
A34
2	Asphalt	LS_264	Nighttime Reflectivity	Not Available for Nighttime Failure	A31
3	Asphalt	LS_302	Reflective Marker Missing

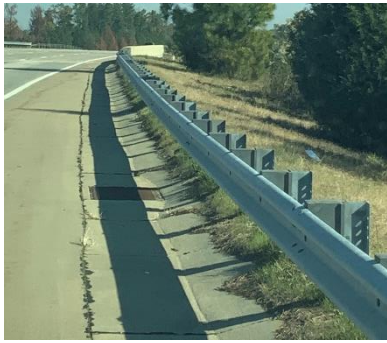
#	Material Type	Object ID	Failure Type	Photo	GIS Reference Page
1	Concrete	LS_58	Missing & Nighttime Reflectivity

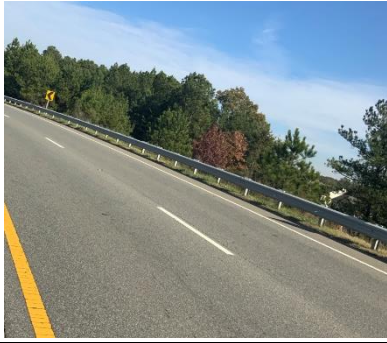
A6
2	Asphalt	LS_214	Missing & Nighttime Reflectivity

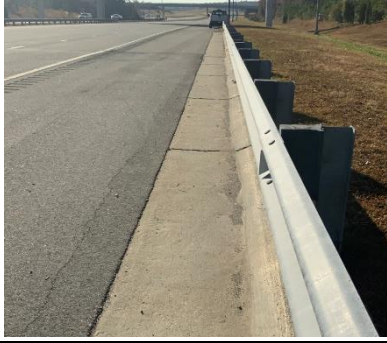
A3
3	Asphalt	LS_296	Missing & Nighttime Reflectivity

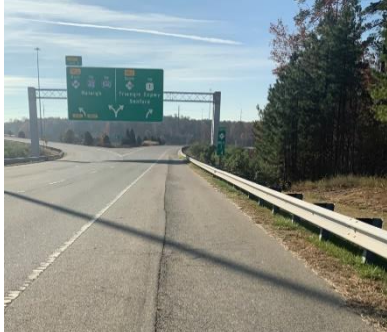
A36
4	Asphalt	LS_302	Missing & Nighttime Reflectivity

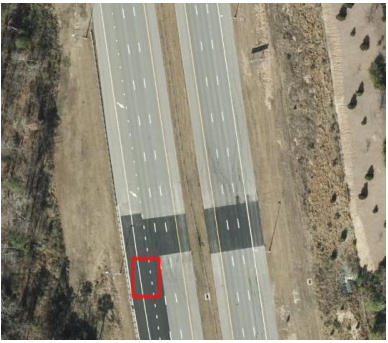
#	Material Type	Object ID	Failure Type	Photo	GIS Reference Page
1	Merge Left	PS_65	Daytime Assessment

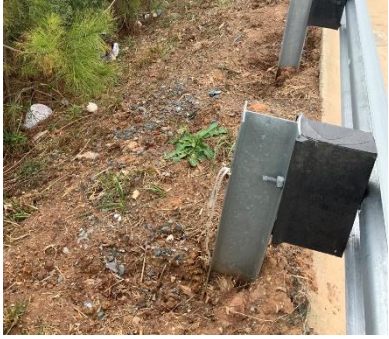
#	Material Type	Object ID	Failure Type	Photo	GIS Reference Page
1	Turf	TF_301	Bare Ground

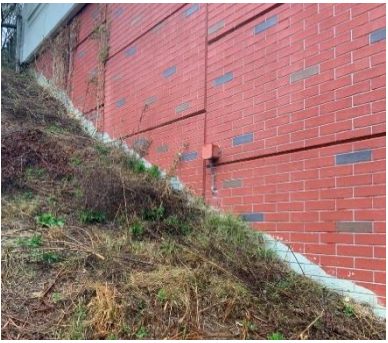
#	Material Type	Object ID	Failure Type	Photo	GIS Reference Page
1	Sound Wall	WL_51	Paint Scale

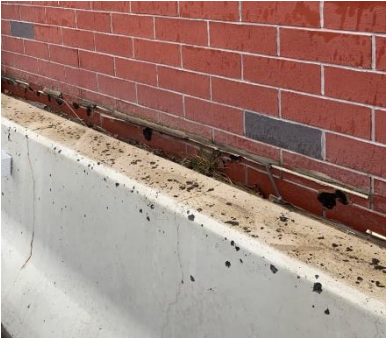
A21
2	Sound Wall	WL_95	Unsealed Cracks
