NORTH CAROLINA
Turnpike Authority

Maintenance Rating Program

Triangle Expressway

2020 Second Quarter Report

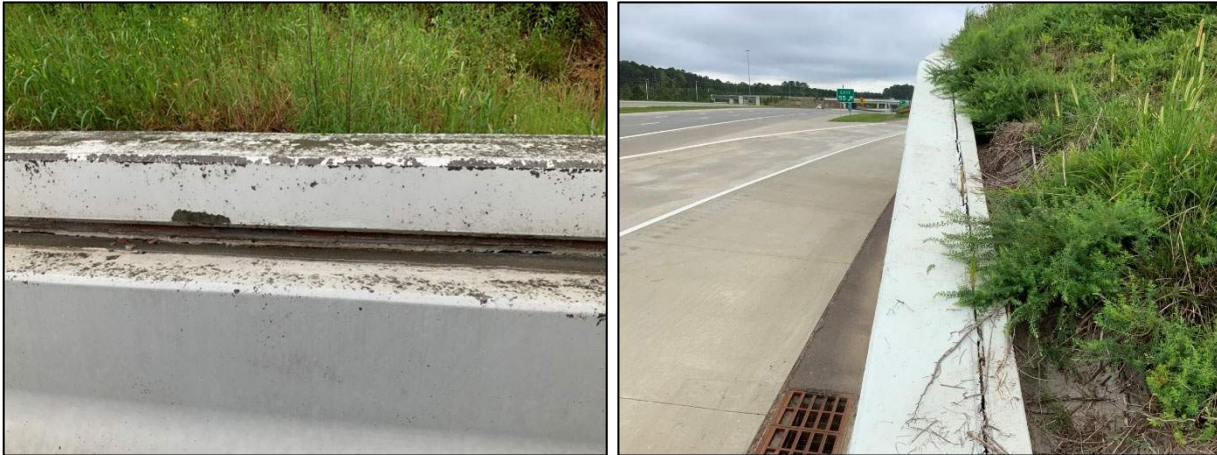
Figure 3: Retaining and Sound Barrier Walls Inspection Results Sample

Retaining Walls and Sound Barrier Walls (73 rating – 4 of the 15 assets did not pass): Out of the 4 retaining wall and sound barrier wall structures that did not pass inspection, 3 had unsealed joints and 1 exhibited cracking and unwanted vegetation growth. Two of the wall segments that did not pass inspection are presented in **Figure 3**.

In accordance with *NCTA Roadway and Facility Maintenance Standards V6*, referenced below, it is recommended that the maintenance provider plan for and schedule joint repairs within the annual work program and that unwanted vegetation is removed upon observation.

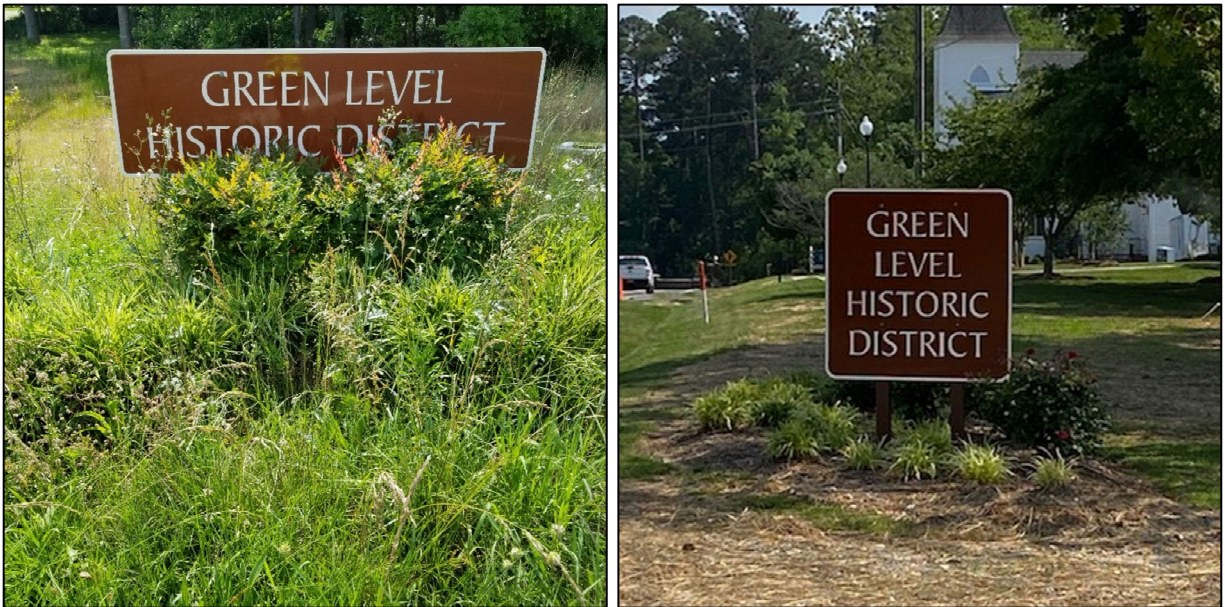
Figure 4: Green Level West Historic District Signs, Landscape Areas

As part of each quarterly inspection, an assessment team visits the two Green Level Historic District signs to conduct a visual inspection of each sign and ensure they are in good standing. One sign, shown first in **Figure 4**, at the corner of Beaver Dam Rd and Green Level W Rd was found to be overgrown and in need of maintenance to the landscaped area. The other sign in the inspection inventory was found to be in good condition, with the landscaped area being well maintained. **Figure 4** shows the two signs assessed.

This quarter, the two Green Level Historic District signs inspected were found to be in good condition while the third sign was identified to have been removed for a Town of Cary development project near Green Level West Road. The landscaped area surrounding one of the two signs was found to be overgrown and in need of maintenance. The landscape area around the other sign on Green Level Church Road was found to be well maintained.

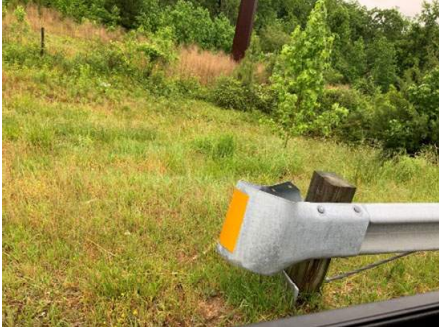
#	Material Type	Object ID	Failure Type	Photo	GIS Reference Page
1	Guardrail	BR_82	Functional Damage

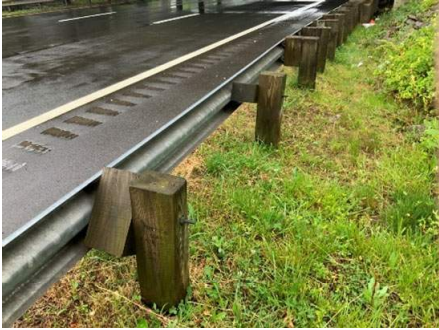
A14
2	Guardrail	BR_202	Twisted Blocks

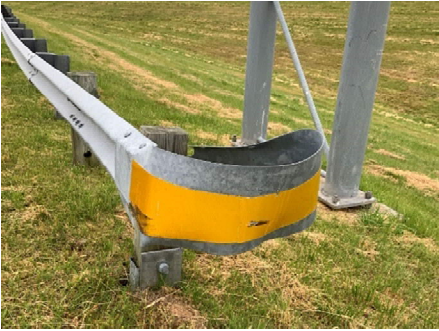
A30
3	Guardrail	BR_260	Functional Damage

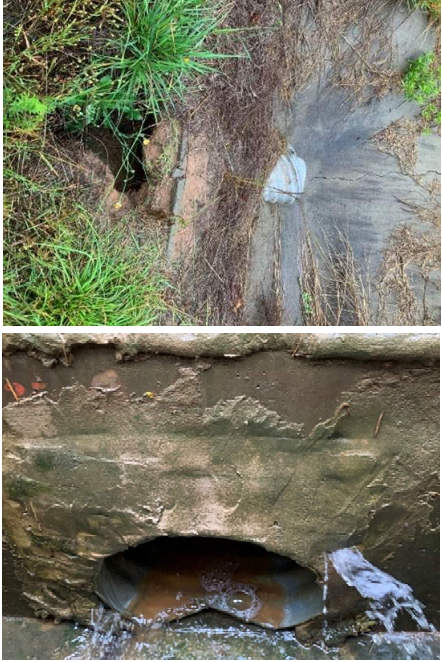
#	Material Type	Object ID	Failure Type	Photo	GIS Reference Page
1	Drainage Pipe	DP_48	Erosion / Water Infiltration

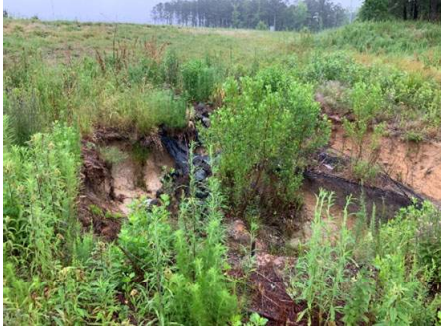
#	Material Type	Object ID	Failure Type	Photo	GIS Reference Page
3	Drainage Pipe	DP_846	Erosion

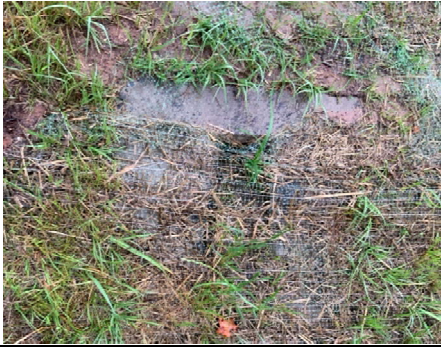
#	Material Type	Object ID	Failure Type	Photo	GIS Reference Page
1	Shoulder Drain	MDP_7	Obstruction

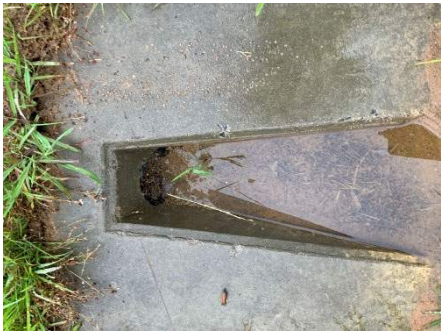
A13
3	Shoulder Drain	MDP_142	Obstruction

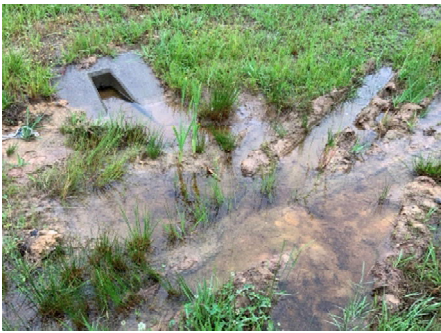
A24
4	Shoulder Drain	MDP_157	Obstruction / End Damage

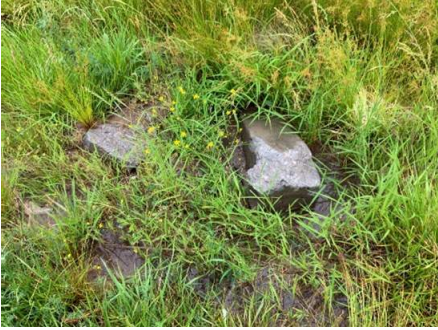
#	Material Type	Object ID	Failure Type	Photo	GIS Reference Page
5	Shoulder Drain	MDP_204	End Damage

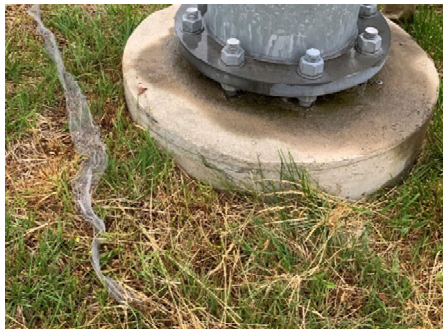
#	Material Type	Object ID	Failure Type	Photo	GIS Reference Page
5	High Mast	HL_232	Rodent Screen

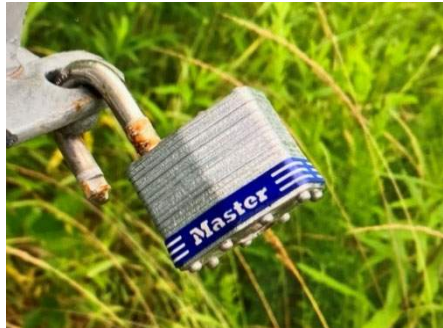
A3
6	High Mast	HL_320	Part Damage

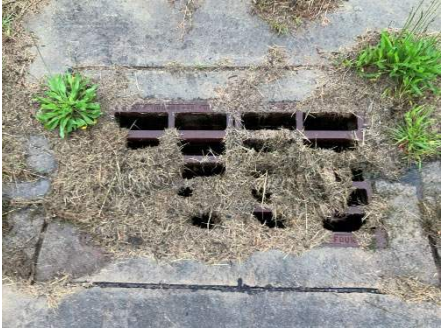
#	Material Type	Object ID	Failure Type	Photo	GIS Reference Page
1	Inlet	IN_7	Obstruction

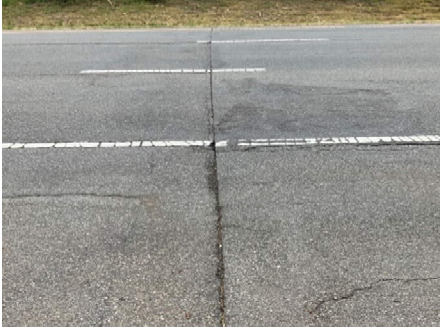
#	Material Type	Object ID	Failure Type	Photo	GIS Reference Page
1	Asphalt	LS_227	Unsealed Cracks

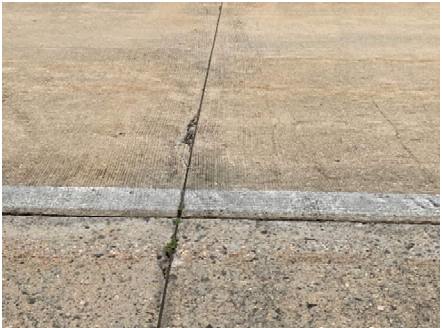
#	Material Type	Object ID	Failure Type	Photo	GIS Reference Page
1	Concrete	LS_208	Joint Malfunction

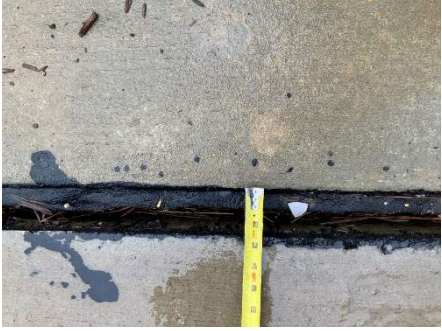
#	Material Type	Object ID	Failure Type	Photo	GIS Reference Page
1	Concrete	LS_73	Joint Separation

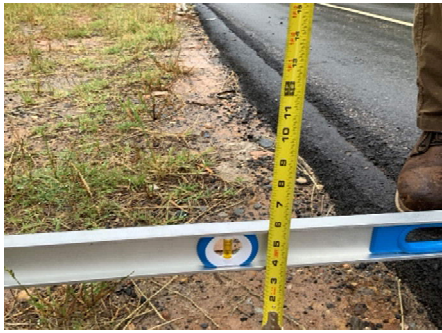
#	Material Type	Object ID	Failure Type	Photo	GIS Reference Page
1	Asphalt	LS_22	Drop Off

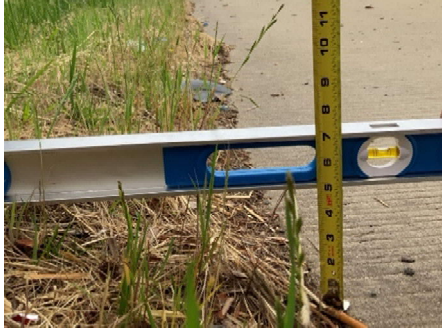
#	Material Type	Object ID	Failure Type	Photo	GIS Reference Page
5	Concrete	LS_594	Build Up

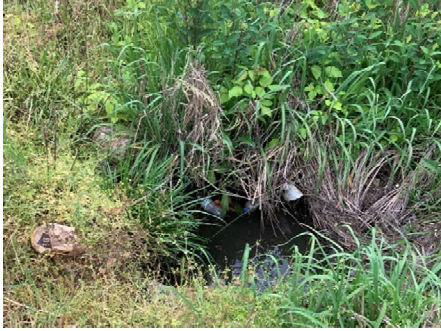
#	Material Type	Object ID	Failure Type	Photo	GIS Reference Page
1	Asphalt	LS_692	Ditch Erosion

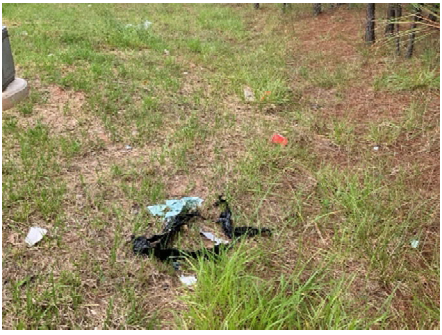
#	Material Type	Object ID	Failure Type	Photo	GIS Reference Page
1	Concrete	LS_594	Litter

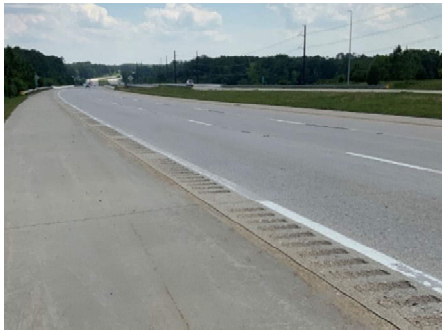
#	Material Type	Object ID	Failure Type	Photo	GIS Reference Page
1	Concrete	LS_105	Line Missing

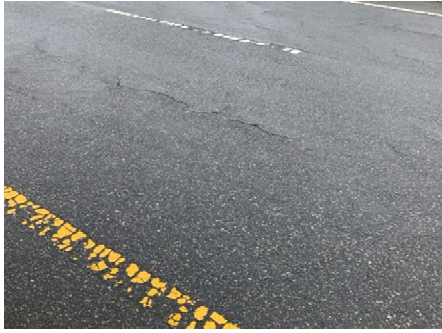
A15, A16
2	Concrete	LS_363	Nighttime Reflectivity	Not Available for Nighttime Failure	A1
3	Asphalt	LS_581	Line Width

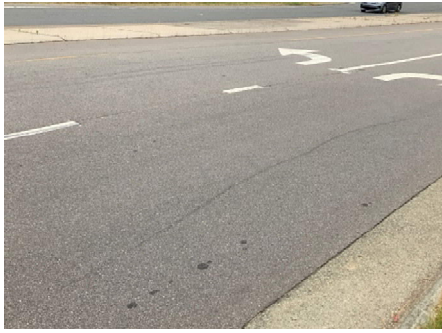
A3, A4
4	Asphalt	LS_692	Line Missing

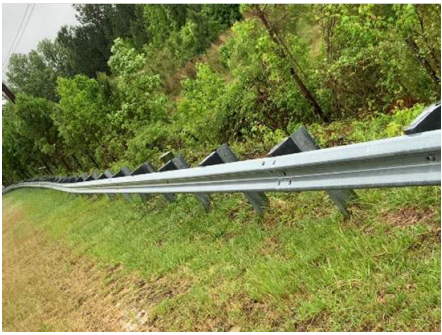
#	Material Type	Object ID	Failure Type	Photo	GIS Reference Page
1	Asphalt	LS_46	Delineators Missing / Nighttime Reflectivity

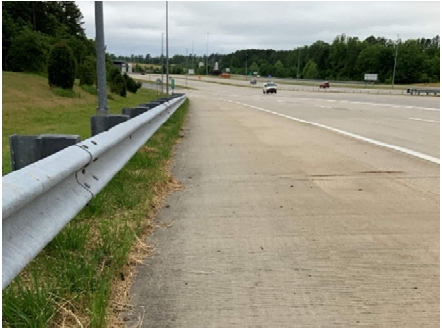
A13
2	Concrete	LS_316	Delineators Missing / Nighttime Reflectivity

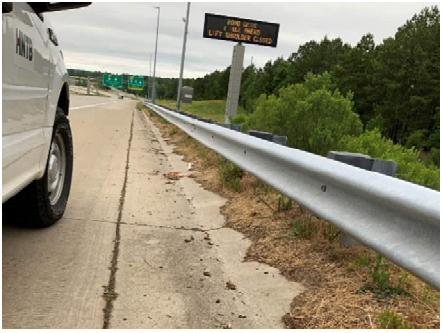
A2
3	Concrete	LS_363	Delineators Missing / Nighttime Reflectivity

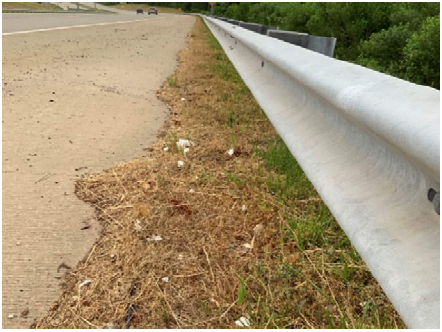
A1
4	Asphalt	LS_391	Nighttime Reflectivity	Not Available for Nighttime Failure	A29
5	Concrete	LS_732	Delineators Missing / Nighttime Reflectivity

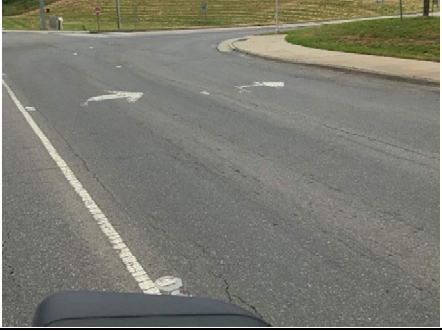
#	Material Type	Object ID	Failure Type	Photo	GIS Reference Page
1	Right Turn	PS_414	Daytime Assessment / Nighttime Reflectivity

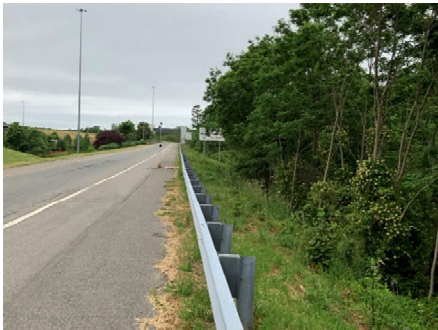
#	Material Type	Object ID	Failure Type	Photo	GIS Reference Page
1	Tree and Brush	TB_430	Sight Distance

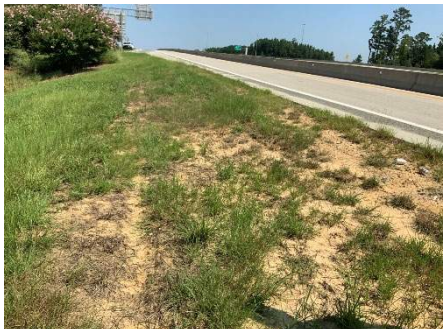
#	Material Type	Object ID	Failure Type	Photo	GIS Reference Page
9	Turf	TF_498	Bare Ground

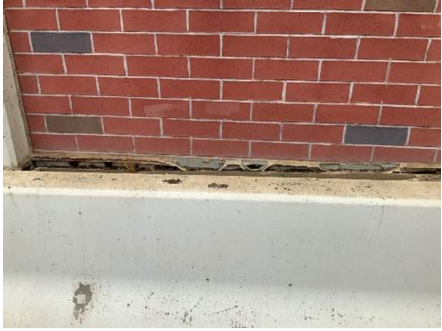
#	Material Type	Object ID	Failure Type	Photo	GIS Reference Page
1	Sound Wall	WL_47	Unsealed Joints

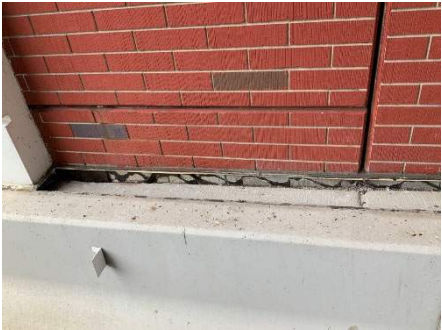
A20
2	Bridge Wall	WL_63	Unsealed Joints

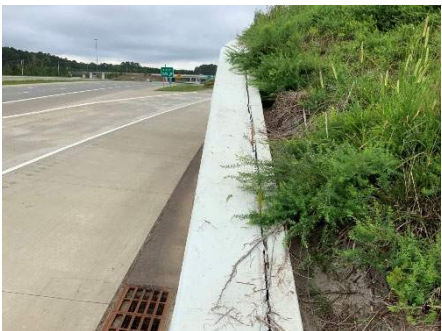
A24
3	Retaining Wall	WL_116	Unsealed Cracks
