NORTH CAROLINA
Turnpike Authority

Maintenance Rating Program

Triangle Expressway

2017 Fourth Quarter and Annual Report

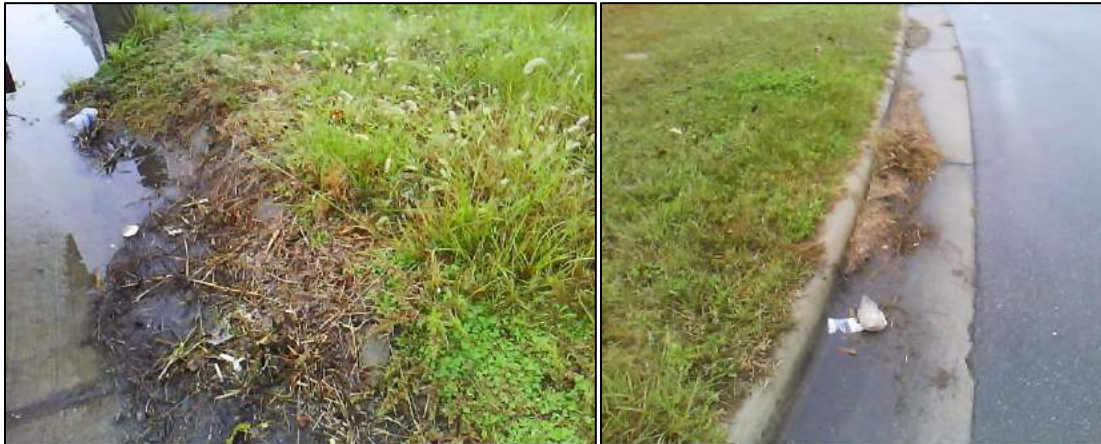
Figure 3: Curb and Gutter Inspection Results Sample

Curb and Gutter (79 rating – 5 of the 24 assets did not pass): Out of the 5 curb and gutter segments that did not pass inspection, 4 were obstructed and 1 had material accumulation. Two of the curb and gutter segments that did not pass inspection are presented in **Figure 3**.

- 1) Settlement greater than 2 inches
- 2) Misalignment greater than 2 inches
- 3) Structural damage is present. Any cracking that is 0.75 inches or greater will be considered damaged.
- 4) Obstructions 2 inches or greater in depth for at least 2 feet of gutter length.

To improve curb and gutter performance throughout the facility, it is recommended that the maintenance provider inspect, sweep, and repair curb and gutter segments pursuant to the *NCTA Roadway and Facility Maintenance Standards V4*, referenced below. During inspections, it is also recommended that the maintenance provider remove any debris accumulation upon routine observations.

- 1) Curb and gutter debris shall be removed upon observation. Routine sweeping of all curb and gutter sections are required once per month.
- 2) Curb and gutter shall be visually inspected for cracks and damage every 4 months.
- 3) Evidence of damage shall be scheduled for repair within the annual work program.

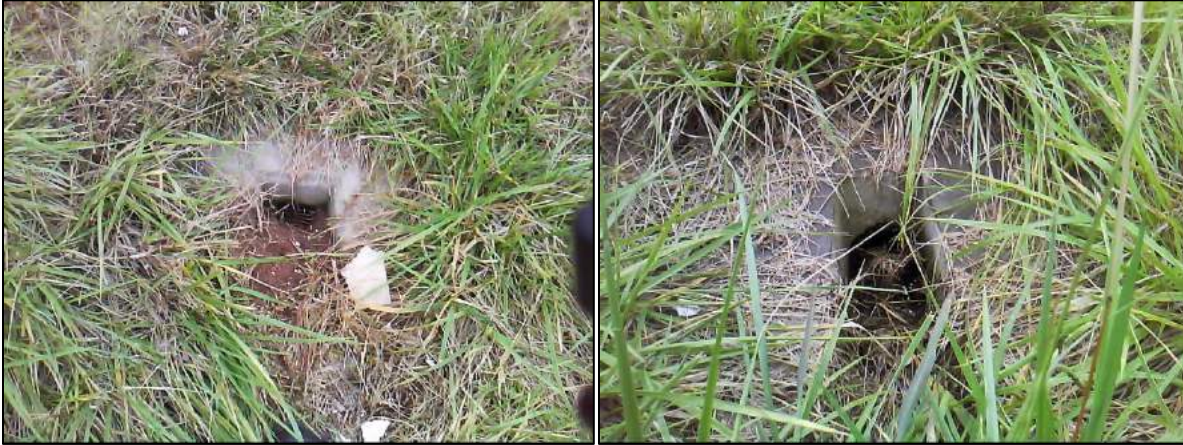
Figure 4: Miscellaneous Drainage Inspection Results Sample

Miscellaneous Drainage (74 rating – 9 of the 35 assets did not pass): Out of the 9 miscellaneous drainage structures that did not pass inspection, 5 were obstructed and 4 had damage at the outlet. Two of the miscellaneous drainage structures (shoulder underdrains) that did not pass inspection are presented in **Figure 4**.

- 1) More than 50% of the structure (length and depth) is obstructed or blocked.
- 2) End protection has deteriorations, erosions, washouts or buildups adversely affecting the natural flow of water.

Some of the obstruction failures are a result of inadequate gradient flow away from the edge drain outlets. To avoid affecting the natural flow of water near the drainage features and potential pavement failures, it is recommended that outlet elevations be checked against the outflow ditch elevations to ensure positive drainage. Appropriate grading of the ditch line may be necessary to provide positive flow.

In accordance with *NCTA Roadway and Facility Maintenance Standards V4*, referenced below, the maintenance provider shall plan annual cleaning of these drainage features to remove any debris or overgrown vegetation. It is also recommended that the maintenance provider continue to follow the routine patrol schedule and repair any erosion or soil buildup problems along the ditch line near the outlets. Edge drains are a critical component of extending the life cycle of pavements as they provide a means for water to drain away from the subgrade and base.

- 1) Miscellaneous Drainage Structures shall be inspected during routine patrols.
- 2) Clear all outlets to edge drains annually.
- 3) Schedule cleanouts and repairs during inspections.

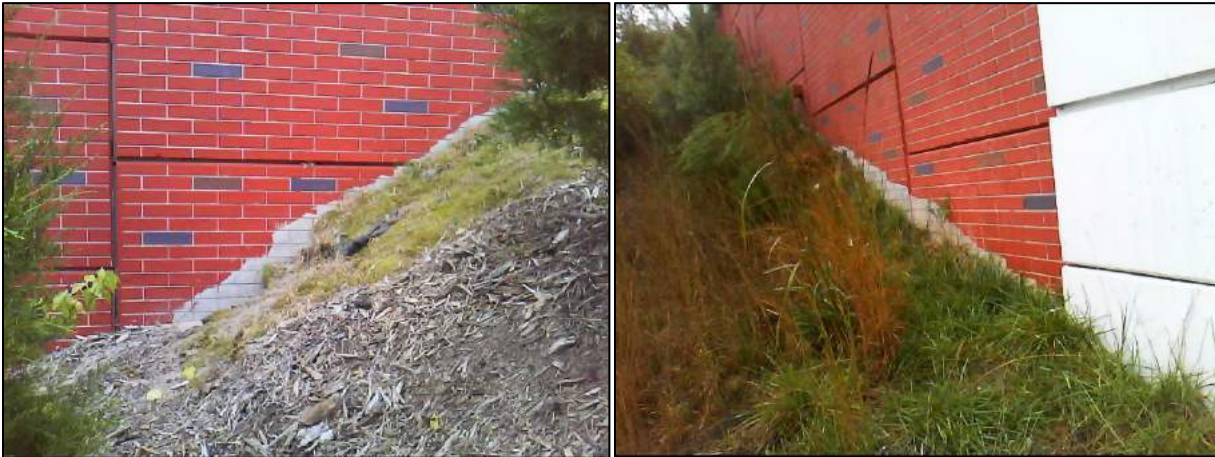
Figure 5: Retaining and Sound Barrier Walls Inspection Results Sample

Retaining Walls and Sound Barrier Walls (73 rating – 4 of the 15 assets did not pass): Out of the 4 retaining wall and sound barrier wall structures that did not pass inspection, 3 had paint scaling and 1 unwanted vegetation growth. Two of the wall segments that did not pass inspection are presented in **Figure 5**.

- 1) More than 10% of exposed surface is covered with unwanted vegetation.
- 2) Any single spall 1 inch deep or greater or cumulative spalls in excess of 1 inch deep over 5 SF.
- 3) More than 25% of weep holes within the sample section are not functioning properly.
- 4) Unsealed cracks or joints greater than 0.25 inches in width.
- 5) Stained areas exhibit cumulative scaling in excess of 1 SF.

In accordance with *NCTA Roadway and Facility Maintenance Standards V4*, referenced below, it is recommended that the maintenance provider plan for and schedule paint repairs within the annual work program and that unwanted vegetation is removed upon observation.

- 1) Walls shall be inspected during daily patrols.
- 2) Unwanted vegetation and graffiti (see graffiti standard) shall be scheduled for removal.
- 3) Minor wall or column damage shall be scheduled for repair within the annual work program.
- 4) Staining damage shall be scheduled for repair within the annual work program.
- 5) Any structural damage that poses a safety risk shall be scheduled immediately upon observation. Mitigate any safety hazard upon observation.

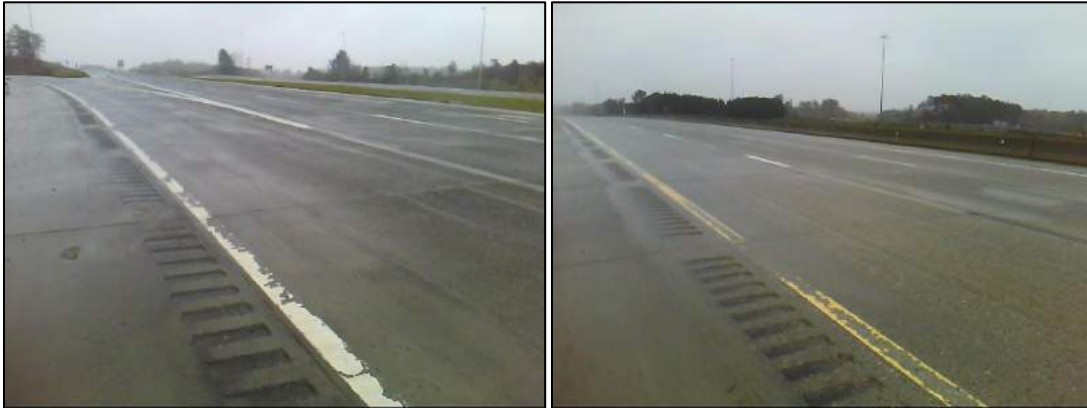
Figure 6: Pavement Striping/Marking Inspection Results Sample

Pavement Striping/Marking (68 rating – 11 of the 34 assets did not pass): Out of the 11 pavement striping/markings segments that did not pass inspection, 9 segments had missing sections or did not meet the required line width, and 2 segments did not reflect during the night. Two of the pavement striping and marking segments that did not pass inspection are presented in **Figure 6**.

- 1) More than 10% of the length of any line is less than 5.4 inches wide.
- 2) More than 10% of each line is not visible at a distance of 160 feet during nighttime observation.
- 3) More than 10% of the length of any line is missing.
- 4) More than 10% of the length of any line is covered by soil, grass, or debris.

Pavement striping/markings were installed along portions of Triangle Expressway over 5 years ago. Understanding that the lifespan of epoxy paint is 3 to 5 years, NCTA has made preparations in its capital budget and work schedule for the replacement of pavement striping/markings. A pavement striping replacement contract for Toll NC-540 is scheduled to be awarded in spring of 2018, and work is expected to be completed by the end of 2018.

To maintain a well-defined lane delineation throughout the Triangle Expressway, it is recommended that the maintenance provider consider scheduling pavement striping/markings replacement cycles in accordance with the *NCTA Roadway and Facility Maintenance Standards V4*, referenced below.

- 1) Pavement striping is observed daily and inspected every 4 months for compliance to the standard.
- 2) Worn or missing markings are evaluated for compliance annually, and generally are scheduled on a 3-5 year replacement cycle depending on the material.

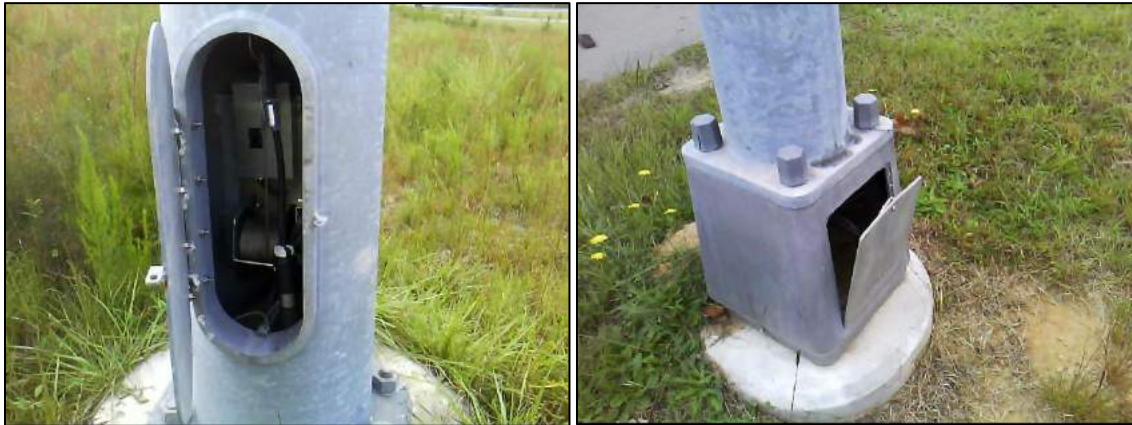
Figure 7: Highway Lighting Inspection Results Sample

Highway Lighting (68 rating – 13 of the 41 did not pass): Out of the 13 highway lights that did not pass inspection, 6 had functional damage, 5 had damaged parts, and 2 had missing parts. Two of the highway lights that did not pass inspection are presented in **Figure 7**.

- 1) Any electrical inspection plate, access panel cover, exposed electrical wire, or pull box cover are not properly secured in place.
- 2) More than 10% of the total luminaries are not functioning during nighttime observation.
- 3) More than 10% of the poles are damaged or missing.
- 4) Rodent screen protection is not in place.

To increase this asset's rating, it is recommended that all non-functioning or damaged highway lights noted during the inspection be repaired and/or replaced in accordance with the *NCTA Roadway and Facility Maintenance Standards V4*, referenced below.

- 1) Perform night patrol once a month, and identify any outages. A monthly "Lighting Outage Report" shall be submitted by the maintenance provider to the NCTA by the 30th of each month. All bulb outages must be replaced within 48 hours.
- 2) Perform cleaning of glassware at the same time as any routine maintenance function or diagnostic action is performed.
- 3) Replace any light poles damaged by traffic within 5 days or within 14 days if any foundations need pouring.

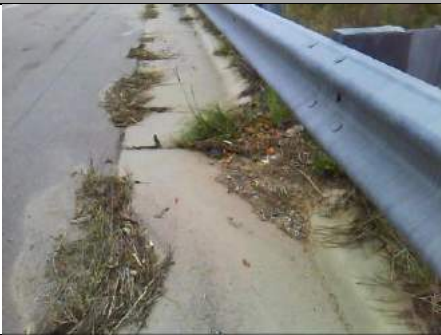
#	Material Type	Object ID	Failure Type	Photo	GIS Reference Page
5	Valley	CG_275	Obstruction

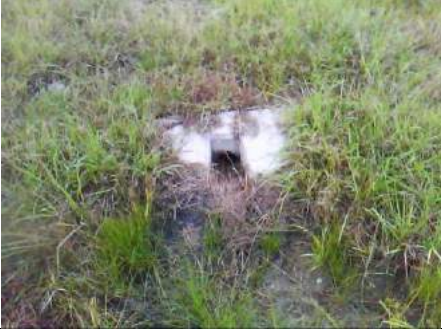
#	Material Type	Object ID	Failure Type	Photo	GIS Reference Page
1	Inlets and Basins	MDP_12	Grate Damage

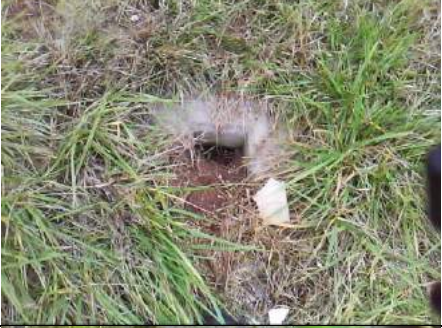
A11
2	Inlets and Basins	MDP_41	Obstruction

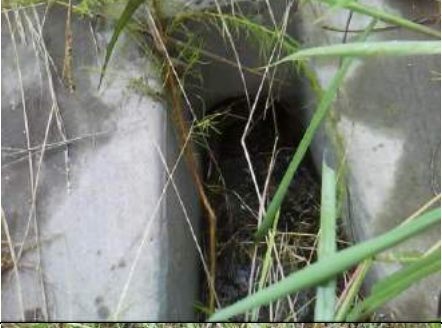
A17
3	Inlets and Basins	MDP_100	Grate Damage

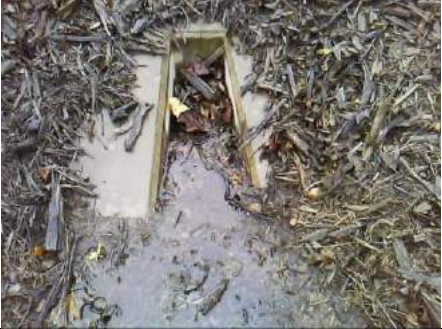
#	Material Type	Object ID	Failure Type	Photo	GIS Reference Page
5	Inlets and Basins	MDP_115	Obstruction

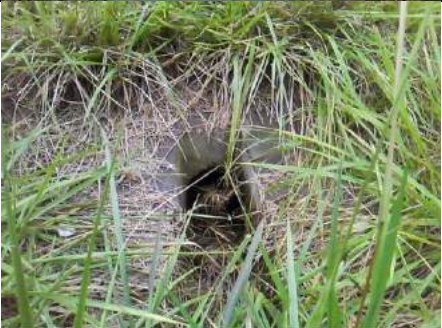
A29
6	Inlets and Basins	MDP_129	Grate Damage

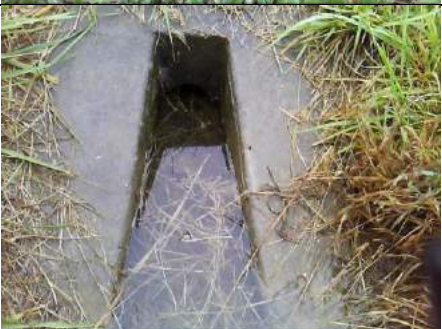
A33
7	Inlets and Basins	MDP_131	Grate Damage

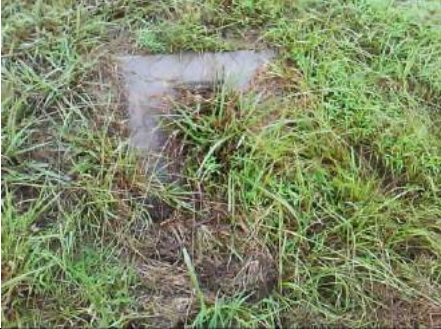
#	Material Type	Object ID	Failure Type	Photo	GIS Reference Page
9	Inlets and Basins	MDP_152	Obstruction

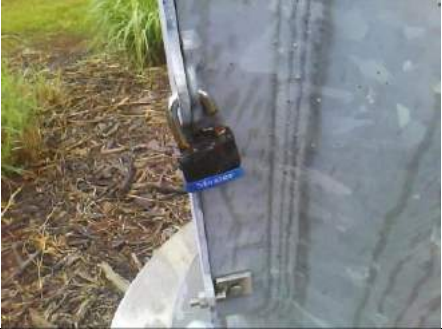
A48
5	High Mast	HL_88	Part Damage

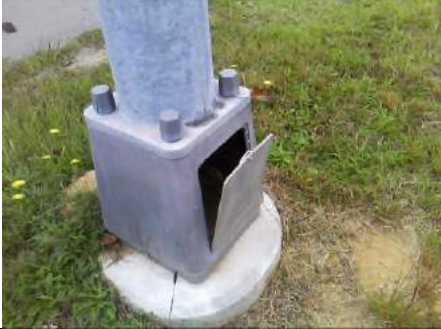
#	Material Type	Object ID	Failure Type	Photo	GIS Reference Page
13	Double Roadway	HL_344	Part Damage

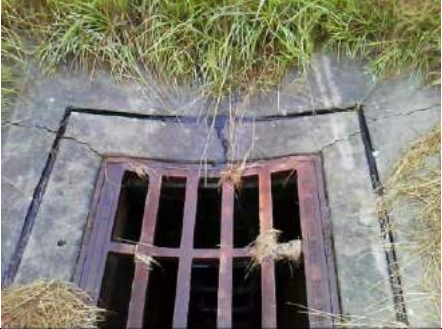
#	Material Type	Object ID	Failure Type	Photo	GIS Reference Page
1	Inlets	IN_309	Surface Damage

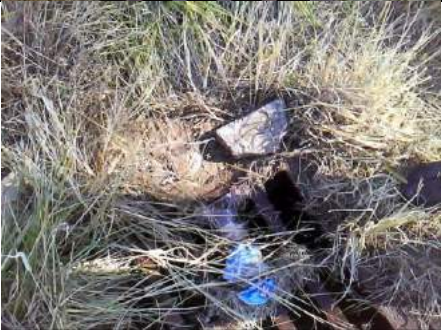
A5
2	Inlets	IN_480	Surface Damage

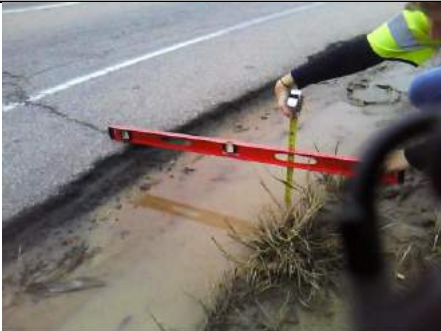
#	Material Type	Object ID	Failure Type	Photo	GIS Reference Page
1	Ramp	LS_5	Shoulder Drop

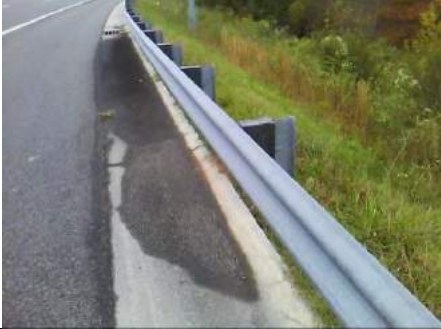
#	Material Type	Object ID	Failure Type	Photo	GIS Reference Page
1	Ramp	LS_189	Roadway Sweeping

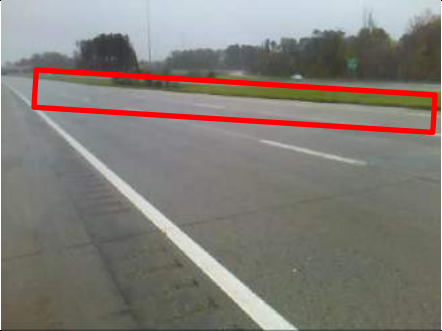
#	Material Type	Object ID	Failure Type	Photo	GIS Reference Page
6	Concrete	LS_437	Line Missing, Line Width

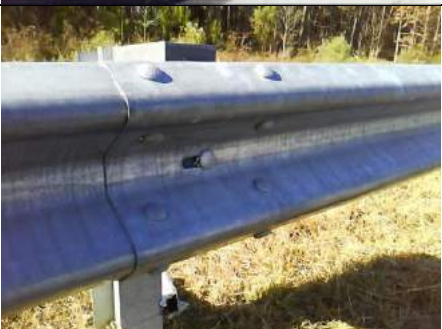
A19
3	Asphalt	LS_189	Missing Markers

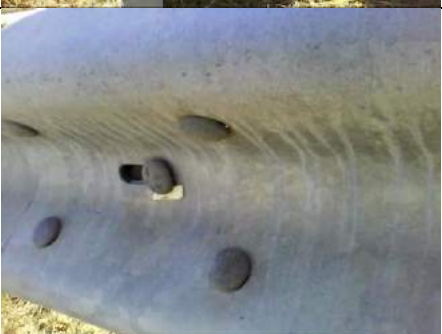
A44
4	Concrete	LS_344	Missing Markers

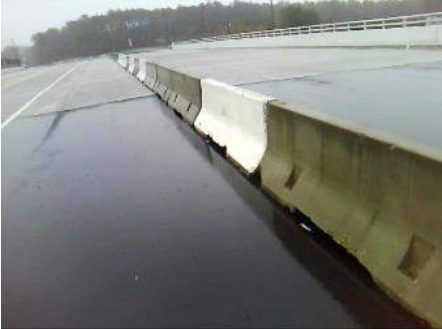
#	Material Type	Object ID	Failure Type	Photo	GIS Reference Page
5	Asphalt	LS_398	Missing Markers

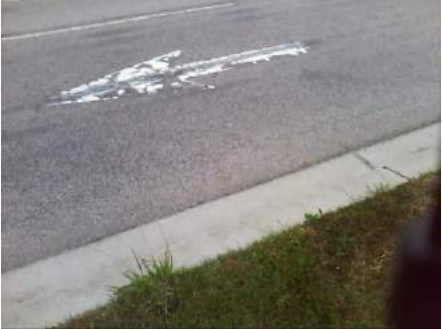
#	Material Type	Object ID	Failure Type	Photo	GIS Reference Page
1	Merge Left	PS_50	Nighttime Reflectivity	Not Available for Nighttime Failure	A12
2	Stop Bar	PS_633	Nighttime Reflectivity	Not Available for Nighttime Failure	A10, A11
3	Thru Arrow	PS_638	Nighttime Reflectivity, Daytime Assessment

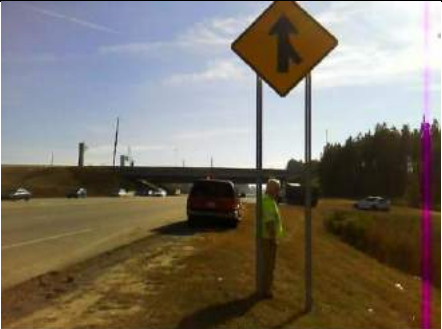
#	Sign Type	Object ID	Failure Type	Photo	GIS Reference Page
1	Authorized Vehicles	SN_167	Nighttime Reflectivity	Not Available for Nighttime Failure	A19
2	Merge	SN_218	Height Requirement

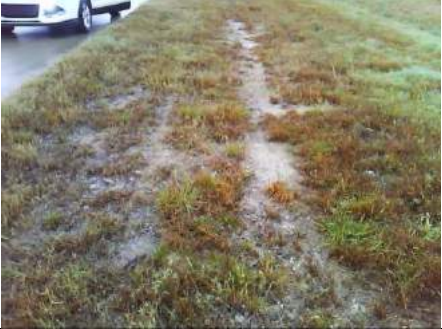
#	Material Type	Object ID	Failure Type	Photo	GIS Reference Page
9	Turf	TF_541	Bare Ground

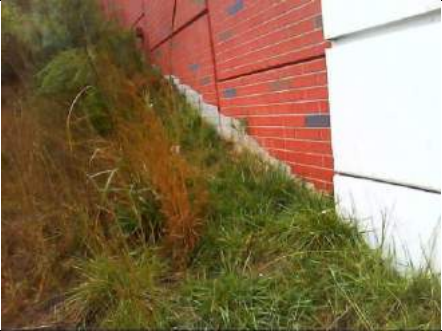
#	Material Type	Object ID	Failure Type	Photo	GIS Reference Page
1	MSE Wall	WL_70	Paint Scaling
