NORTH CAROLINA
Turnpike Authority

Maintenance Rating Program

Triangle Expressway

2018 Third Quarter Report

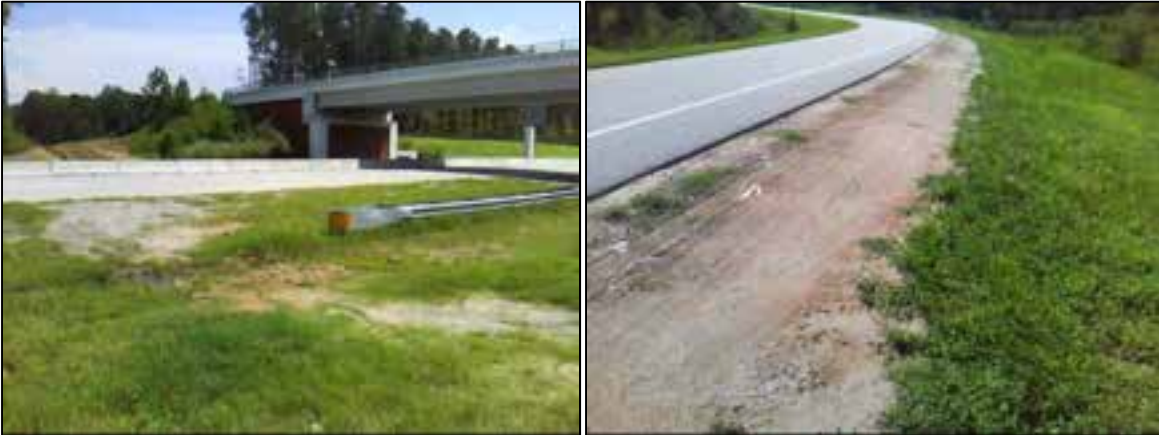
Figure 3: Turf Areas

Turf Condition (85 rating – 9 of the 62 assets failed). All 9 turf areas that did not pass the inspection were due to bare ground conditions. Two examples of these turf areas are presented in **Figure 3**.

To continue to improve the Turf Condition rating, it is recommended that the maintenance provider continue the established aggressive schedule for seeding and fertilization cycles of bare ground areas throughout the rest of the summer season and possibly into early fall. Some areas will require scarifying of the soil as these areas are heavily compacted and inundated with aggregate. Additionally, as part of the 2018 mowing cycle the maintenance provider should continue to closely monitor mowing heights to avoid turf scalping pursuant to the NCTA Roadway and Facility Maintenance Standards V4, referenced below.

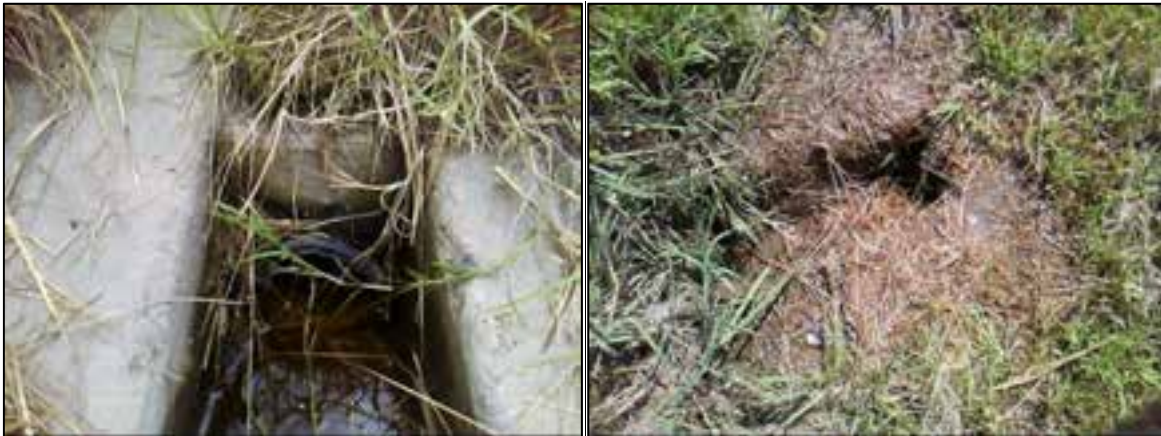
Figure 4: Miscellaneous Drainage

Miscellaneous Drainage (81 rating – 6 of the 31 assets failed). Out of the 6 miscellaneous drainage structures that did not pass the inspection, 2 were obstructed and 4 had missing rodent screens. Two of these structures are presented in **Figure 4**.

In accordance with *NCTA Roadway and Facility Maintenance Standards V4*, referenced below, the maintenance provider shall plan annual cleaning of these drainage features to remove any debris or overgrown vegetation. It is also recommended that the maintenance provider continue to follow the routine patrol schedule and repair any erosion or soil buildup problems along the ditch line near the outlets. Edge drains are a critical component of extending the life cycle of pavements as they provide a means for water to drain from the subgrade and base.

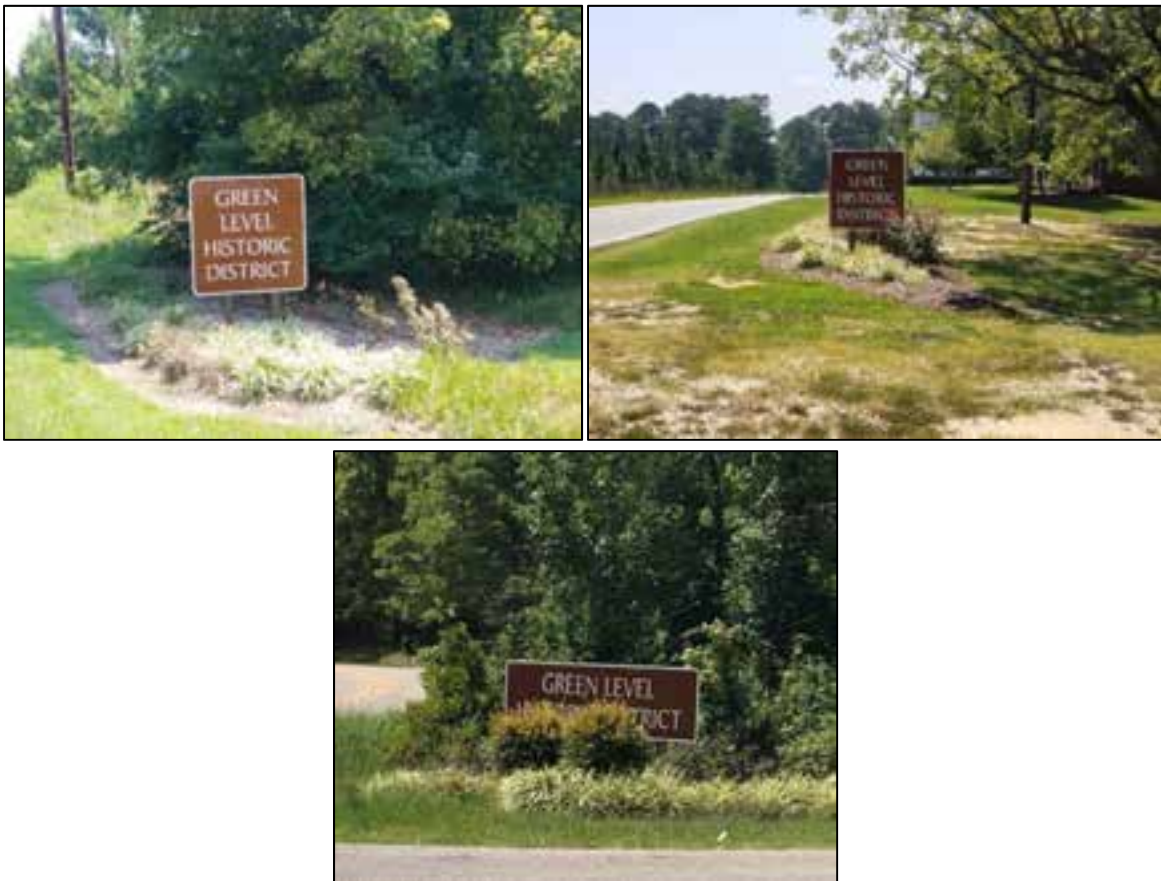
Figure 5: Green Level West Historic District Signs, Landscape Areas

As part of each quarterly inspection, an assessment team visits the three Green Level Historic District signs to conduct a visual inspection of each sign and ensure they are in good standing. The three signs included in the inspection inventory were found to be in good condition, with the landscaped areas being well maintained. *Figure 5* shows these signs.

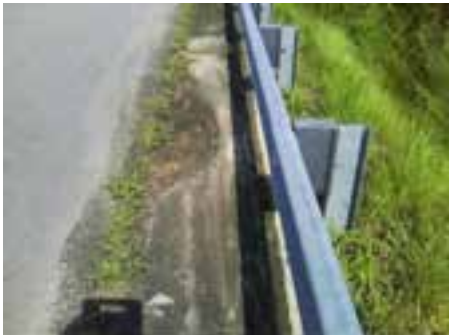
#	Material Type	Object ID	Failure Type	Photo	GIS Reference Page
1	Shoulder Berm Gutter	CG_180	Material Accumulation

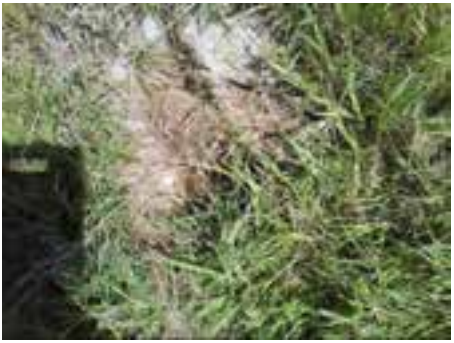
#	Material Type	Object ID	Failure Type	Photo	GIS Reference Page
1	Shoulder Drain	MDP_18	Obstruction

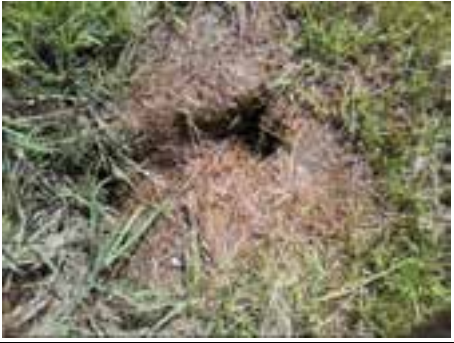
A11
2	Shoulder Drain	MDP_27	Obstruction

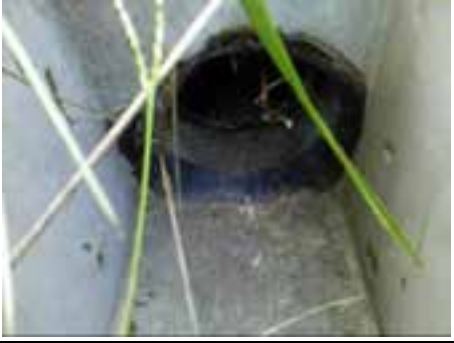
A12
3	Shoulder Drain	MDP_76	Missing Rodent Screen

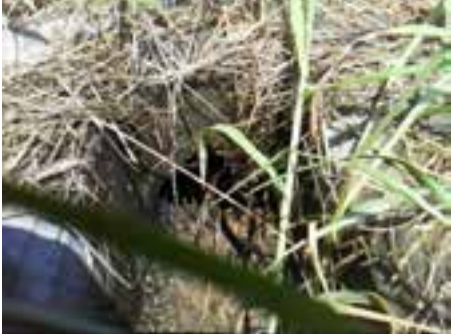
A19
4	Shoulder Drain	MDP_109	Missing Rodent Screen

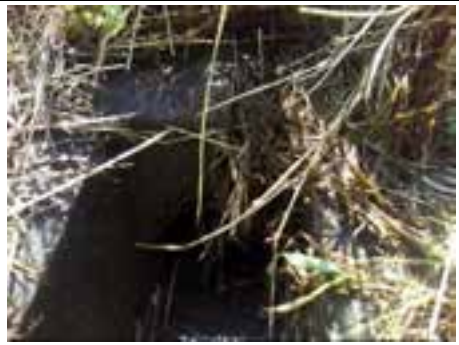
#	Material Type	Object ID	Failure Type	Photo	GIS Reference Page
5	Shoulder Drain	MDP_118	Missing Rodent Screen

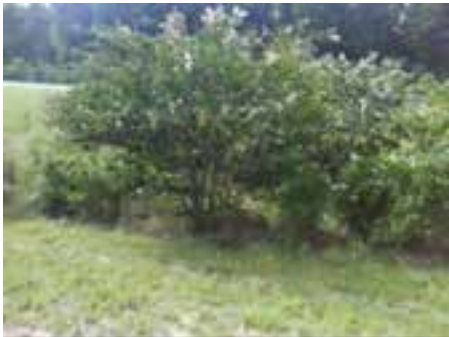
#	Material Type	Object ID	Failure Type	Photo	GIS Reference Page
1	Plant Bed	PB_255	Weeds

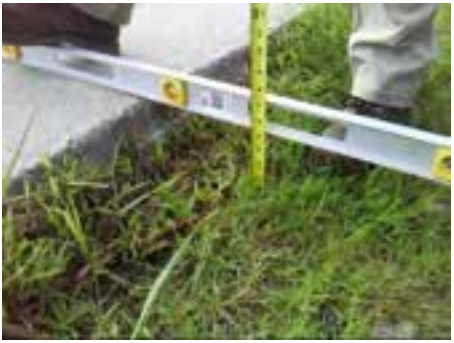
#	Material Type	Object ID	Failure Type	Photo	GIS Reference Page
1	Concrete	LS_159	Shoulder Drop-Off

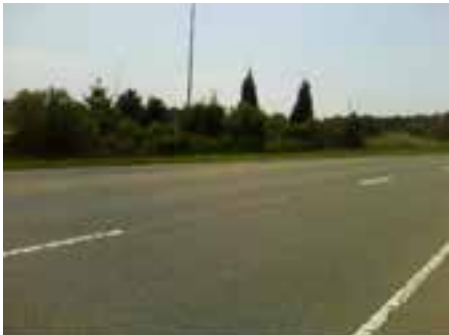
#	Material Type	Object ID	Failure Type	Photo	GIS Reference Page
1	Asphalt	LS_203	Line Missing

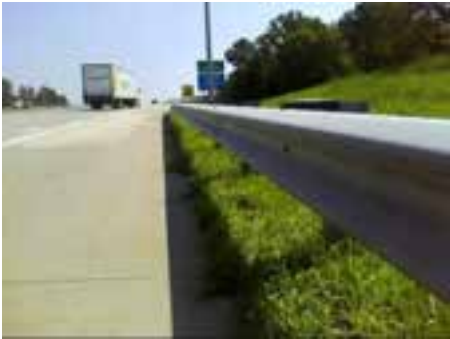
#	Material Type	Object ID	Failure Type	Photo	GIS Reference Page
1	Asphalt	LS_204	Nighttime Reflectivity	Not Available for Nighttime Failure	A42
2	Asphalt	LS_246	Nighttime Reflectivity	Not Available for Nighttime Failure	A44, A45
3	Asphalt	LS_248	Nighttime Reflectivity	Not Available for Nighttime Failure	A44
4	Asphalt	LS_259	Nighttime Reflectivity	Not Available for Nighttime Failure	A41
5	Concrete	LS_318	Nighttime Reflectivity, Missing Delineators

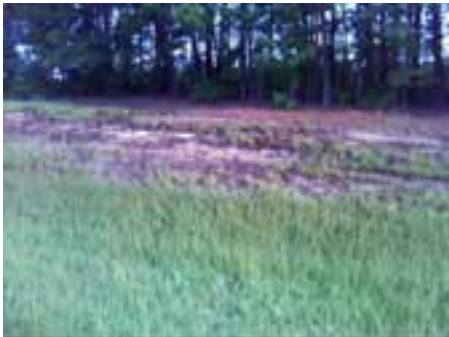
#	Material Type	Object ID	Failure Type	Photo	GIS Reference Page
9	Turf	TF_822	Bare Ground

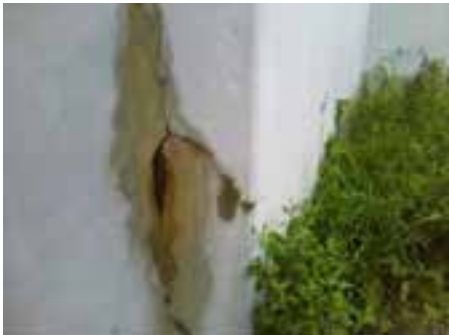
#	Material Type	Object ID	Failure Type	Photo	GIS Reference Page
1	Bridge Wall	WL_32	Paint Scale
