Detailed Visual Inspection

Concrete was the principal material used in the construction of the Bonner Bridge. Concrete elements include the following:

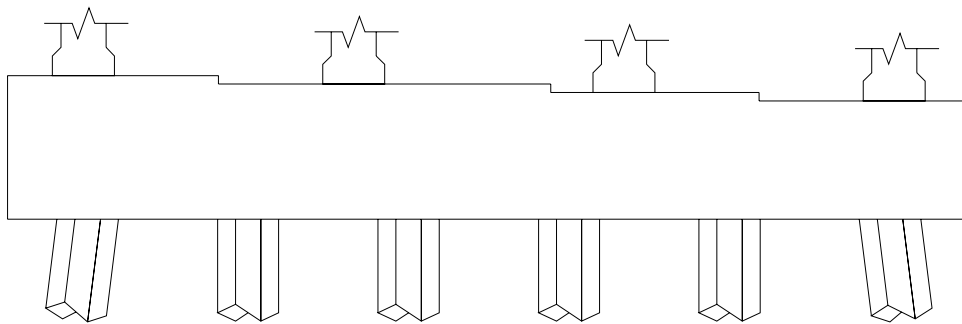
Bent configuration B: Bents 53, 75, 93, 102, 103, 176, 177 and 178

upper edge and wrap up onto the top surface of the pile cap. One fairly small spall with exposed reinforcing steel was observed on the south face, at midspan, at the upper edge. Bent 53 is a type B configuration.

Significant patching was observed on the north elevation and slightly less patching on the south elevation. Several small delaminated areas were detected on the north face, one larger delaminated area was detected on the south face and several small areas were delaminated on the top of the pile cap. One spall (approximately 1 sq. ft.) with exposed reinforcing steel was observed on both the north and south elevations and two larger spalls were found on the top and soffit of the pile cap. Bent 75 is a type B configuration (see Appendix D.2C, pg. D.2C-8).

Relatively minor patching existed on the pile cap, with one patch observed on both the north and south faces. Several delaminated areas were detected in the north elevation, ranging in size from approximately 1 to 2 sq. ft., and a couple smaller delaminated areas were detected on the south face. A fairly small spall with exposed reinforcing steel was found on the north face at the top edge. Bent 93 is a type B configuration (see Appendix D.2C, pg. D.2C-10).

Several patches were observed on the north elevation of the pile cap, with the largest patch containing many vertical hairline cracks. A couple of small patches were found on the south face of the pile cap. Several relatively small (approximately 1-1.5 sq. ft.) delaminated areas were detected in both the north and south face of the pile cap, as well as in the pile cap soffit. Several cracks were found in the pile cap, with a length of 2' or less, with two measured crack widths equal to approximately 0.01". A small spall with exposed reinforcing steel was observed in the south face towards the east end, at the bottom edge. Bent 102 is a type B configuration (see Appendix D.2C, pp. D.2C-10, 11).

Moderate patching was observed on both the north and south elevations of the pile cap, with patch sizes ranging from approximately 1 sq. ft. to 5 sq. ft. Many small to medium size delaminated areas were detected in the north and south faces of the pile cap, as well as the pile cap top and soffit. Several spalls were found in the pile cap, along the lower edge of both the north and south faces, with four locations of exposed reinforcing steel. A crack with a measured width of 0.05" was observed in the north face at the lower west end. Bent 103 is a type B configuration (see Appendix D.2C, pg. D.2C-11).

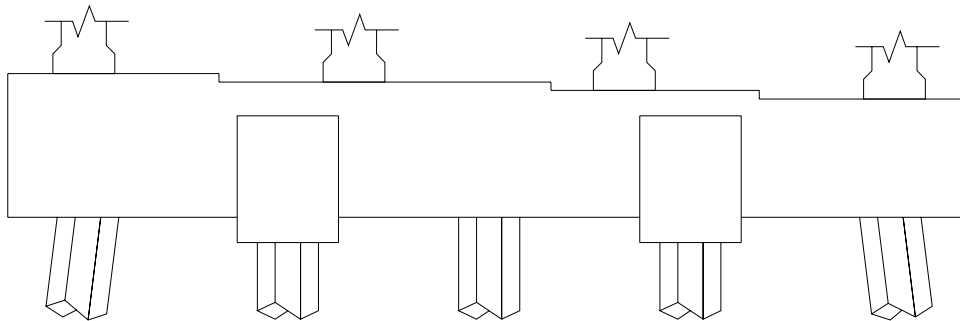
Bent configuration C: Bents 88, 116, 167 and 175

Several large patched areas (approximately 2-4 sq. ft.) were observed on the north face of the pile cap and one medium size patch existed on the south face. All of the patched areas were sound. Several relatively small delaminated areas were detected on the north and south faces and the pile cap soffit. A large spall with exposed reinforcing steel was observed on the south face, along the lower edge, as well as along the lower edges of the short beams atop the north-south battered piles. Bent 88 is a type C configuration (see Appendix D.2C, pp. D.2C-9, 10).

Medium sized patches (approximately 2-4 sq. ft.) were observed on both the north and south elevations. A moderate number of delaminated areas were detected on both the north and south faces and the pile cap top; all in the original concrete. Several of the delaminations contained horizontal cracks; a few with measured widths of 0.04". One delamination on the north face, when sounded, spalled off and released trapped water. Other cracks were observed in the original concrete of both the north and south faces and the top of the pile cap. Some of these cracks had measured widths of 0.04". Bent 116 is a type C configuration.

Several fairly small delaminated areas were detected on the pile cap south elevation and the south faces of the cross-pile caps. A couple small delaminated areas were also detected on the north face and the pile cap top. Several short cracks were observed on the top of the pile cap, the north elevation, the north and south faces of the cross-pile caps and on the east end of the pile cap. The range of measured crack widths was 0.015" to 0.075". Two spalls were observed on the south faces of both of the southern cross-pile caps, one of which had exposed reinforcing steel. Bent 175 is a type C configuration and was retrofit with concrete transfer girders.
