## Maintenance Rating Program

Triangle Expressway

### 2019 Third Quarter Report

### NCTA Triangle Expressway Roadway Maintenance Performance Rating Program; Q3, FY 2019 Rating

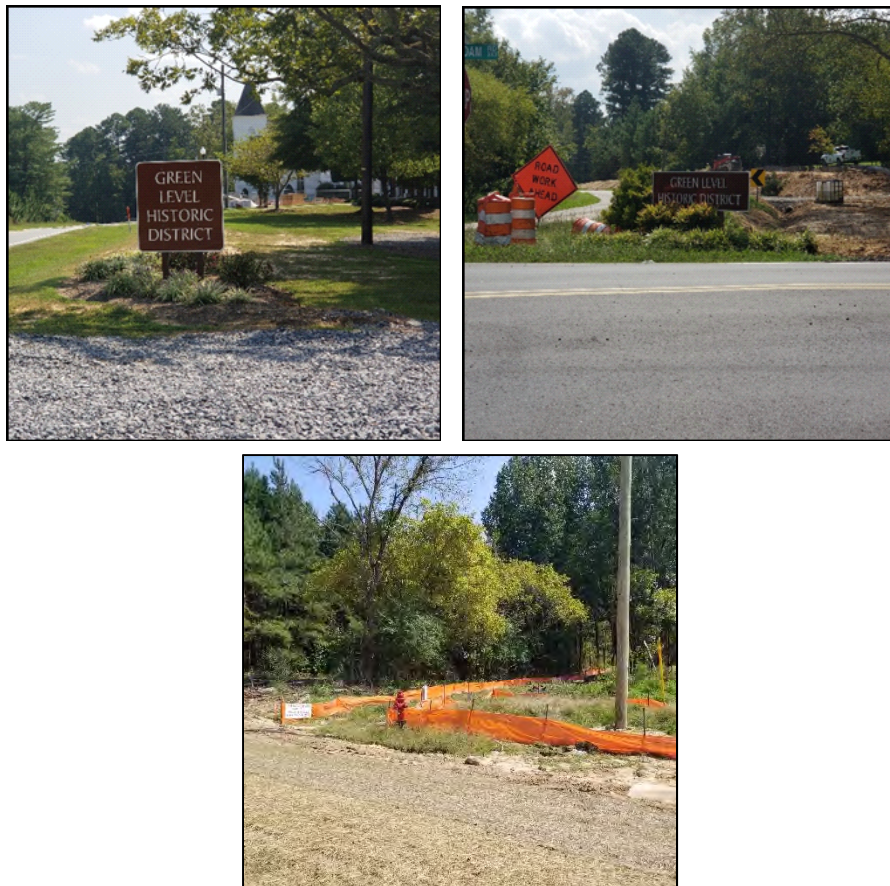
**Figure 4: Green Level West Historic District Signs, Landscape Areas**

As part of each quarterly inspection, an assessment team visits the three Green Level Historic District signs to conduct a visual inspection of each sign and ensure they are in good standing. Two of the three signs included in the inspection inventory were found to be in good condition, with the landscaped areas being well maintained. The third sign had been temporarily removed due to nearby construction activities.

This quarter, the two Green Level Historic District signs inspected were found to be in good condition while the third sign was identified to have been removed for a Town of Cary development project near Green Level West Road. Additionally, the landscaped areas surrounding the signs were found to be well maintained.

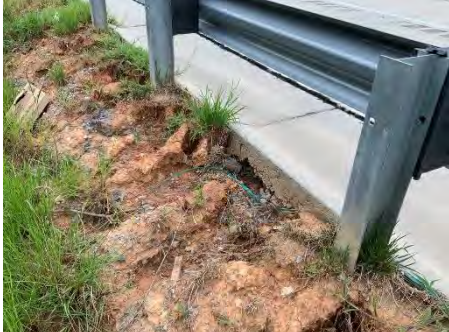
A30
2	Shoulder Berm Gutter	CG_9	Settlement

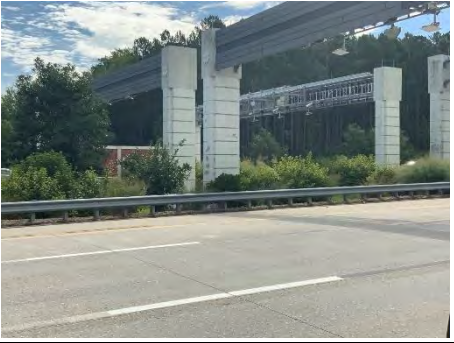
A31
2	Gantry Support	DS_44	Scaling

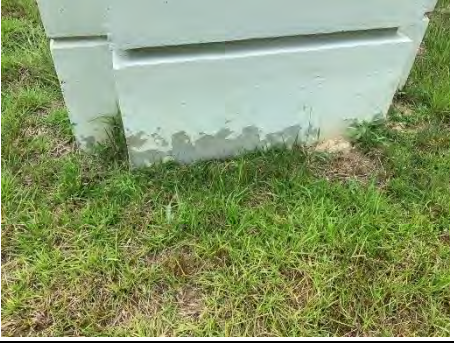
A11
3	Overhead Sign Support	DS_194	Scaling

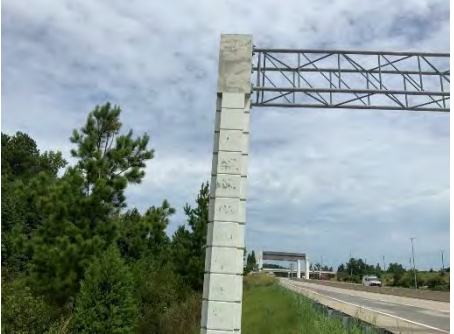
A19
4	Overhead Sign Support	DS_246	Scaling

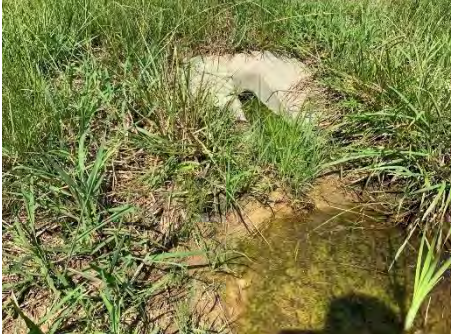
A19
4	Shoulder Drain	MDP_95	Obstruction

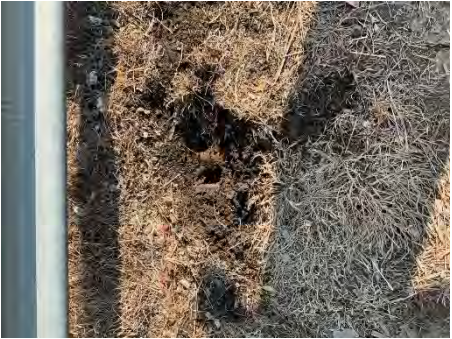
A9
2	Drop Inlet	IN_848	Obstruction

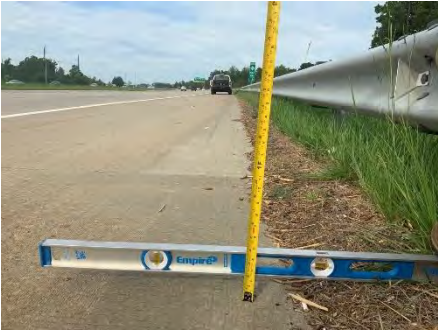
A29
2	Concrete	LS_346	Shoulder Build-Up

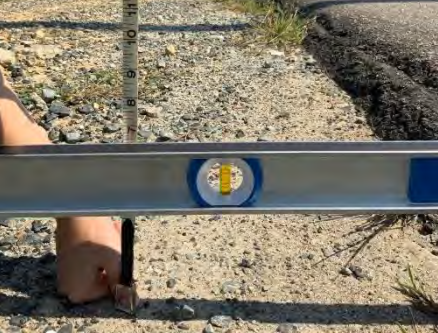
A6
3	Asphalt	LS_545	Shoulder Drop-Off

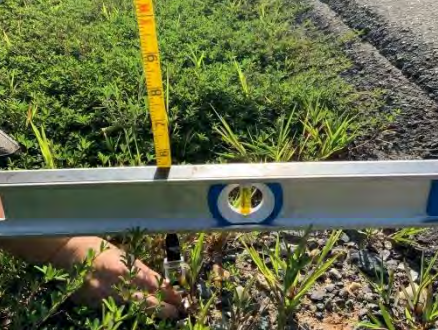
A23
4	Asphalt	LS_552	Shoulder Drop-Off

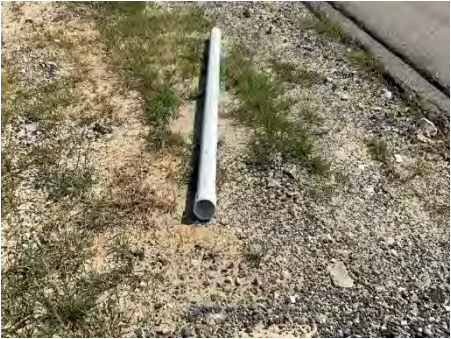
A6
2	Asphalt	LS_545	Litter

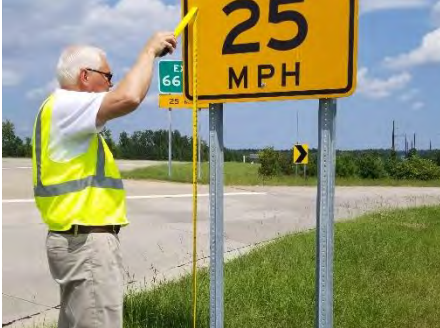
A12
2	Speed Limit Ramp	SN_353	Height Requirement

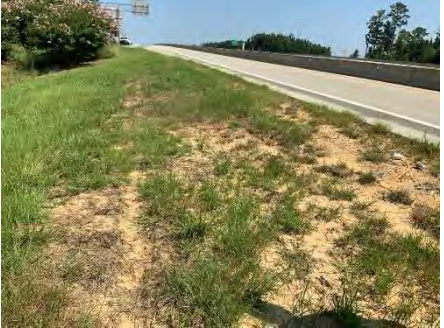
A25
2	Turf	TF_498	Bare Ground

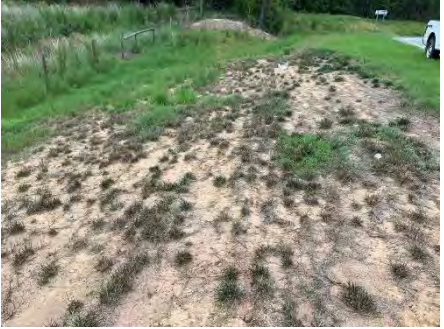
A17
3	Turf	TF_1036	Bare Ground
