NORTH CAROLINA
Turnpike Authority

Maintenance Rating Program

Triangle Expressway

2019 Fourth Quarter and Annual Report

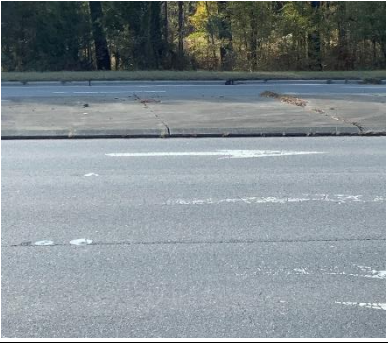
A36
2	Thru Arrow	PS_419	Daytime Assessment

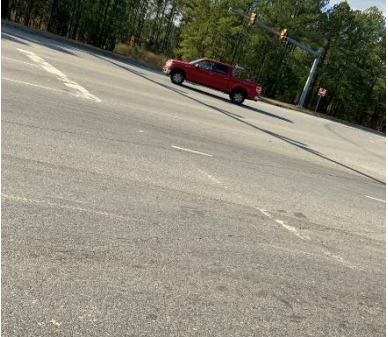
A1
3	Stop Bar	PS_430	Daytime Assessment

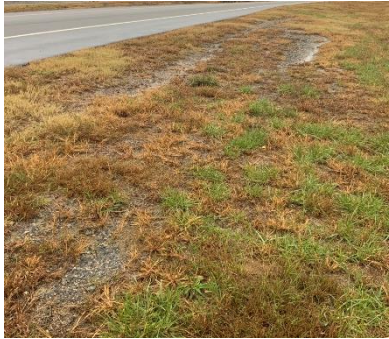
A30
2	Turf	TF_462	Bare Ground

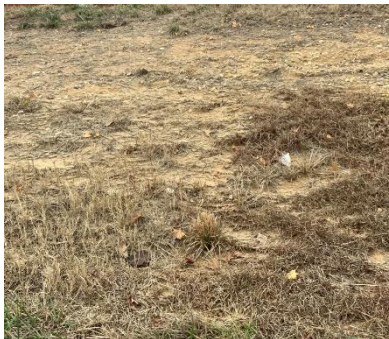
A30
3	Turf	TF_480	Bare Ground
