NORTH CAROLINA
Turnpike Authority

Maintenance Rating Program

Triangle Expressway

2020 Second Quarter Report

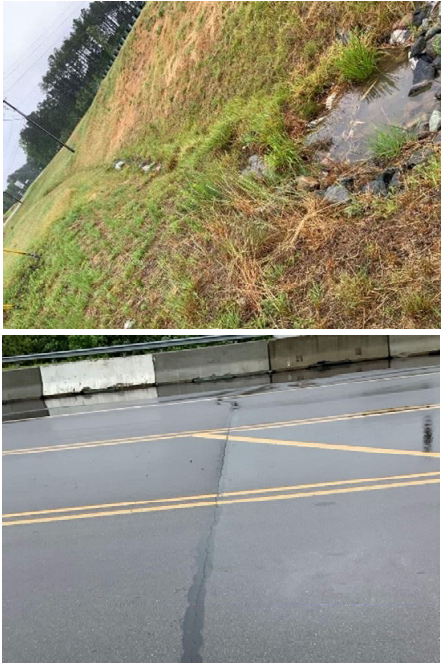
A29
2	Drainage Pipe	DP_61	Obstruction / Roadway Settlement

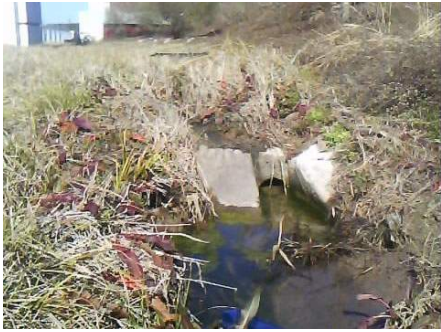
A8
2	Shoulder Drain	MDP_55	Rodent Screen

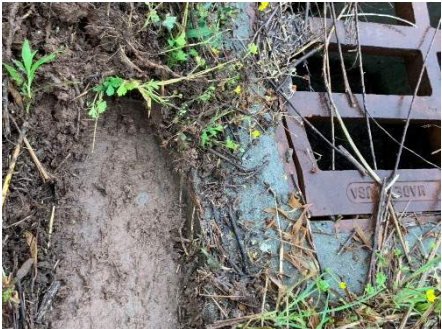
A7
2	Inlet	IN_302	Eroded Area

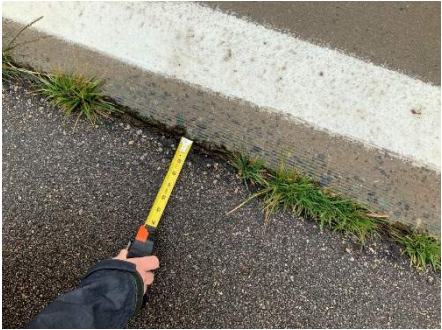
A10
2	Concrete	LS_483	Joint Separation

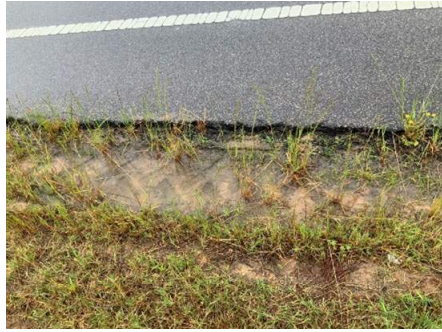
A27
2	Asphalt	LS_46	Drop Off

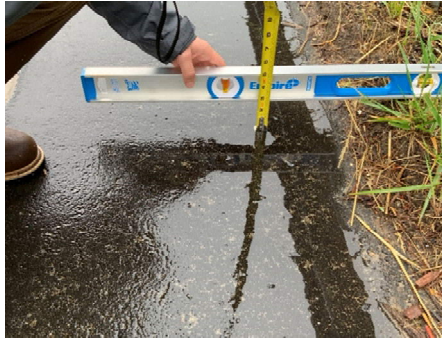
A13
3	Concrete	LS_72	Build Up

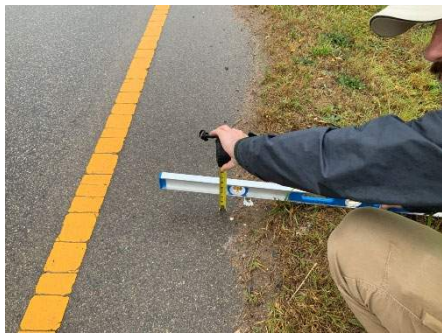
A10
4	Asphalt	LS_391	Build Up

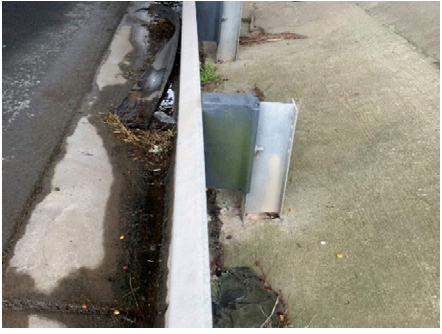
A6
2	Asphalt	LS_719	Litter

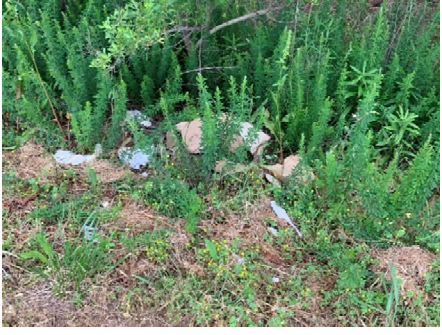
A7
3	Concrete	LS_732	Litter

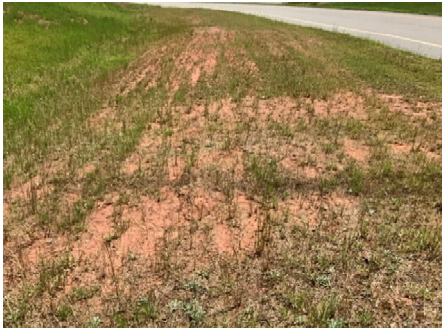
A18
10	Turf	TF_1039	Bare Ground

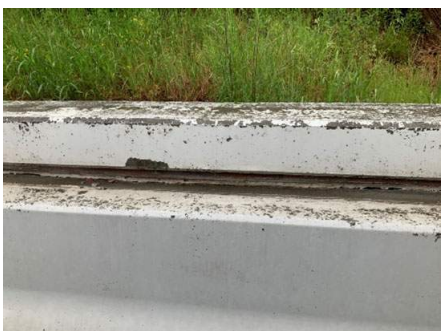
A28
4	Sound Wall	WL_117	Unsealed Joints
