NORTH CAROLINA
Turnpike Authority

Maintenance Rating Program

Triangle Expressway

2017 Fourth Quarter and Annual Report

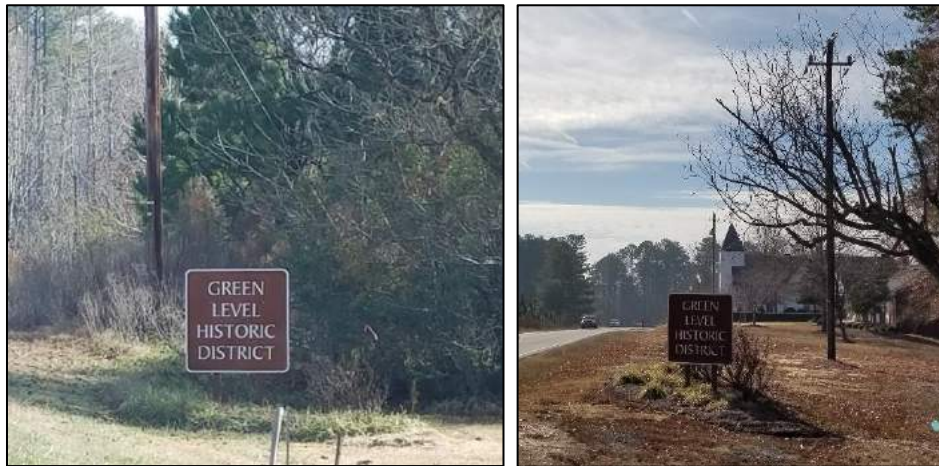
Figure 8: Green Level West Historic District Signs, Landscape Areas

As part of each quarterly inspection, an assessment team visits the four Green Level Historic District signs to conduct a visual inspection of each sign and ensure they are in good standing. During this quarter, the sign located at the intersection of Green Level Church Road and Green Level West Road was excluded from the inspection inventory due to its removal during the completion of a Town of Cary development project near the intersection. The three signs included in the inspection inventory were found to be in good condition, with the landscaped areas being well maintained. **Figure 8** shows two of these signs.

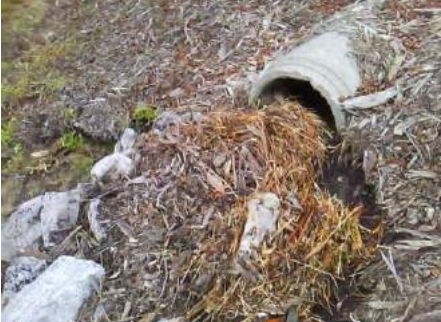
#	Material Type	Object ID	Failure Type	Photo	GIS Reference Page
1	Drain	DP_84	Obstruction

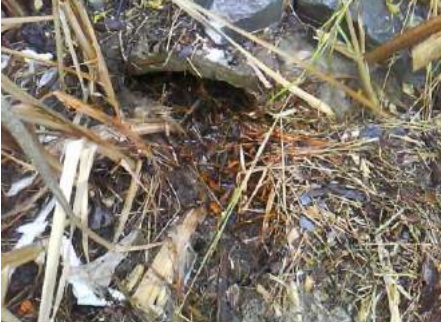
A19
2	Drain	DP_775	Obstruction

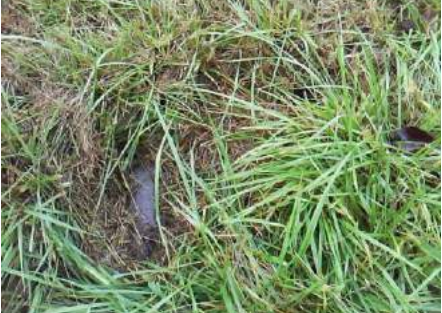
A28
4	Inlets and Basins	MDP_114	Obstruction

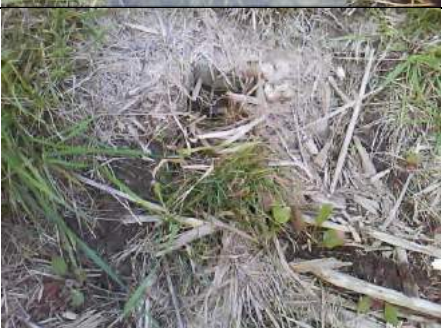
A33
8	Inlets and Basins	MDP_139	Obstruction

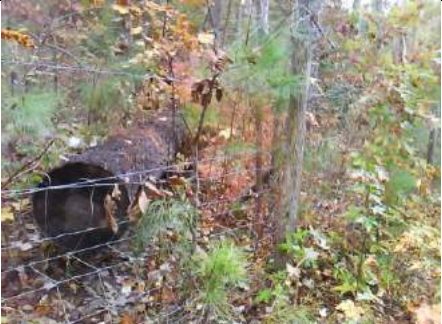
#	Material Type	Object ID	Failure Type	Photo	GIS Reference Page
1	Woven	FN_184	Hole Height

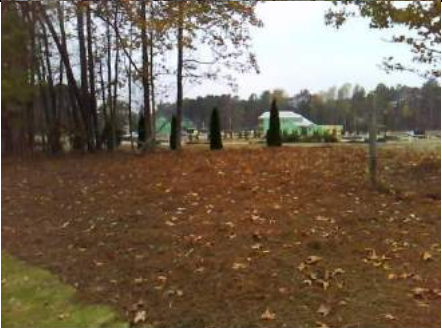
A8
2	Woven	FN_323	Fence Height

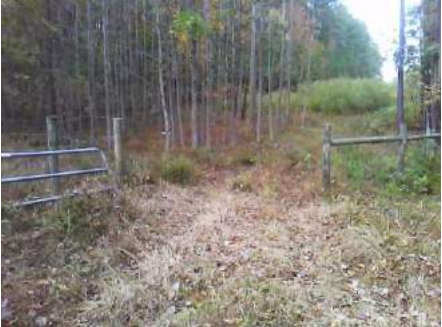
A28
3	Woven	FN_358	Open Gate

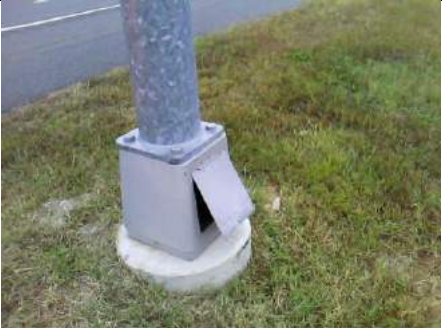
#	Material Type	Object ID	Failure Type	Photo	GIS Reference Page
1	Single Roadway	HL_28	Functional Damage	Not Available for Nighttime Failure	A20
2	Double Roadway	HL_48	Functional Damage	Not Available for Nighttime Failure	A25
3	Single Roadway	HL_81	Functional Damage, Part Damage

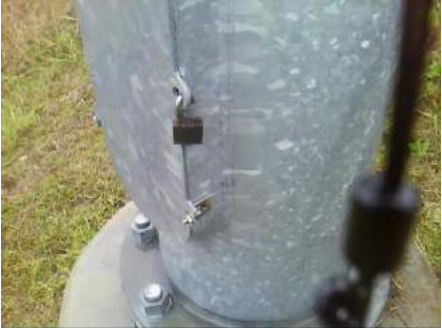
A45
4	High Mast	HL_87	Part Damage

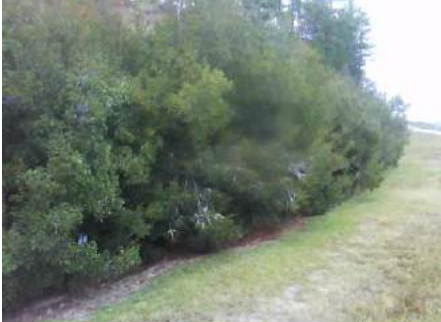
#	Material Type	Object ID	Failure Type	Photo	GIS Reference Page
1	Plant Bed	PB_49	Health

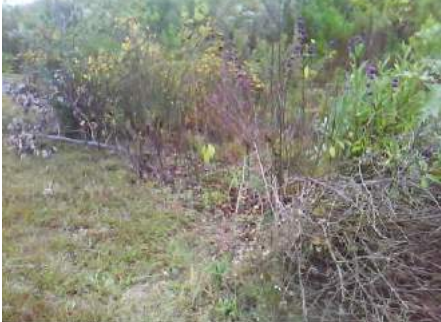
A49
2	Plant Bed	PB_55	Health

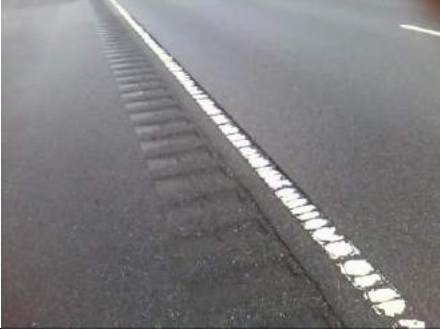
#	Material Type	Object ID	Failure Type	Photo	GIS Reference Page
1	Asphalt	LS_235	Pavement Cracking

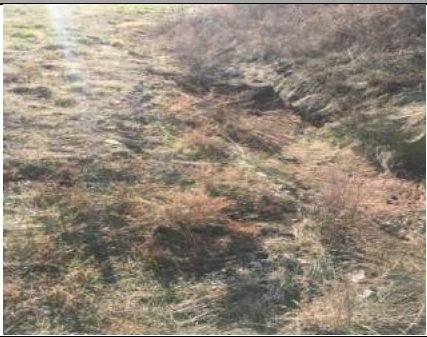
#	Material Type	Object ID	Failure Type	Photo	GIS Reference Page
1	Ramp	LS_300	Ditch Erosion

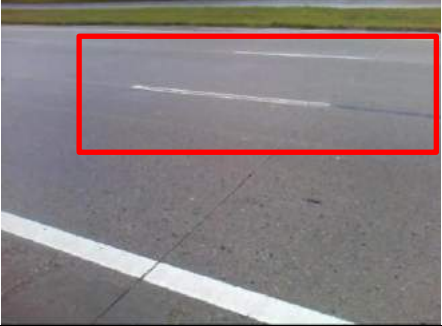
A34
7	Concrete	LS_439	Line Width

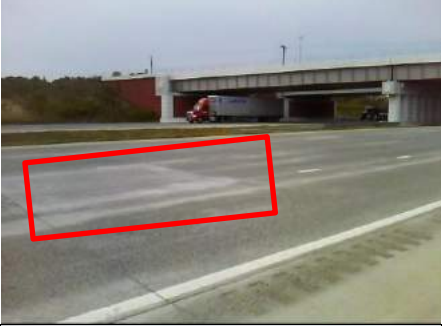
A34
8	Concrete	LS_443	Line Missing, Line Width

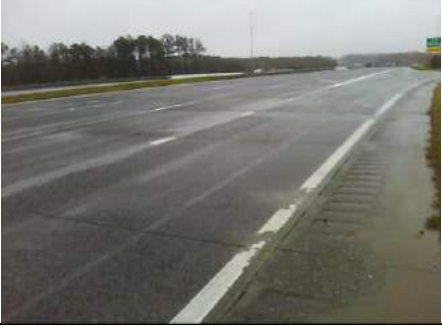
A34, A35
9	Concrete	LS_462	Line Missing, Line Width

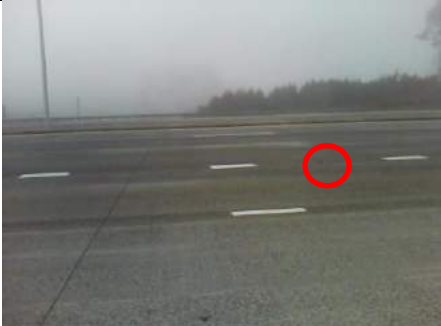
#	Material Type	Object ID	Failure Type	Photo	GIS Reference Page
1	Concrete	LS_475	Missing Markers

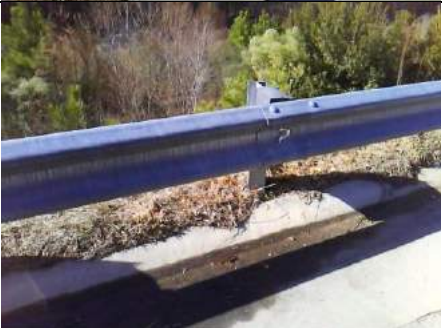
A18
2	Concrete	LS_129	Missing Markers, Nighttime Reflection

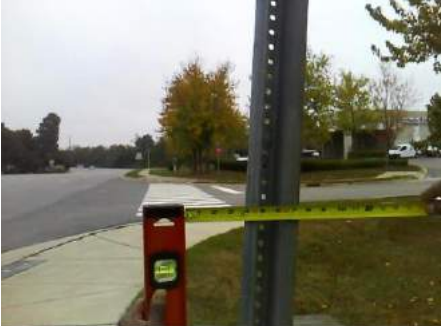
A10
3	Message Board	SN_336	Nighttime Reflectivity	Not Available for Nighttime Failure	A45
4	Other	SN_1023	Leaning

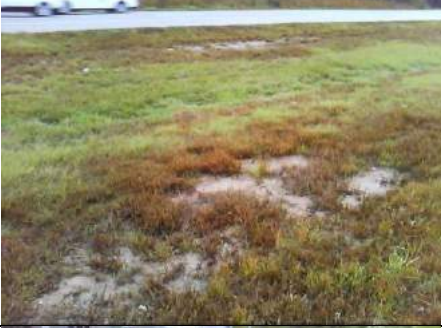
A24
10	Turf	TF_602	Bare Ground

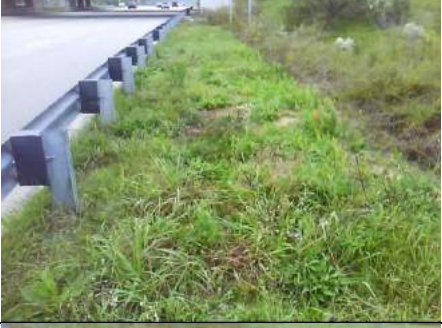
A18
11	Turf	TF_704	Undesirable Vegetation

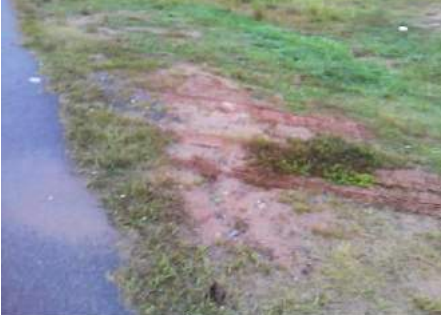
A10
12	Turf	TF_785	Bare Ground
