NORTH CAROLINA
Turnpike Authority

Maintenance Rating Program

Triangle Expressway

2018 Third Quarter Report

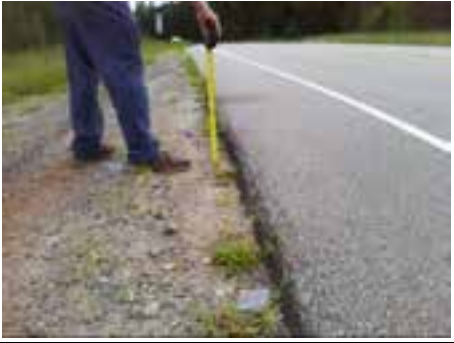
A29
3	Asphalt	LS_552	Shoulder Drop-Off
